**A CASE STUDY
SLOPE INSTABILITIES / REMEDIAL MEASURES
FOR A VIADUCT FOUNDATIONS**

Prof.Dr.Turan Durgunoğlu(1) ,Dr.Andrew Lord(2) ,H.Fatih Kulaç(3)

(1) Professor, Boğaziçi University, Civil Eng. Department, İstanbul
(2) OVE ARUP & Partners, ARUP Geotechnics, London, England
(3) ZETAŞ Earth Technology Corp., Geotechnical Consultancy and Design, İstanbul, Turkey

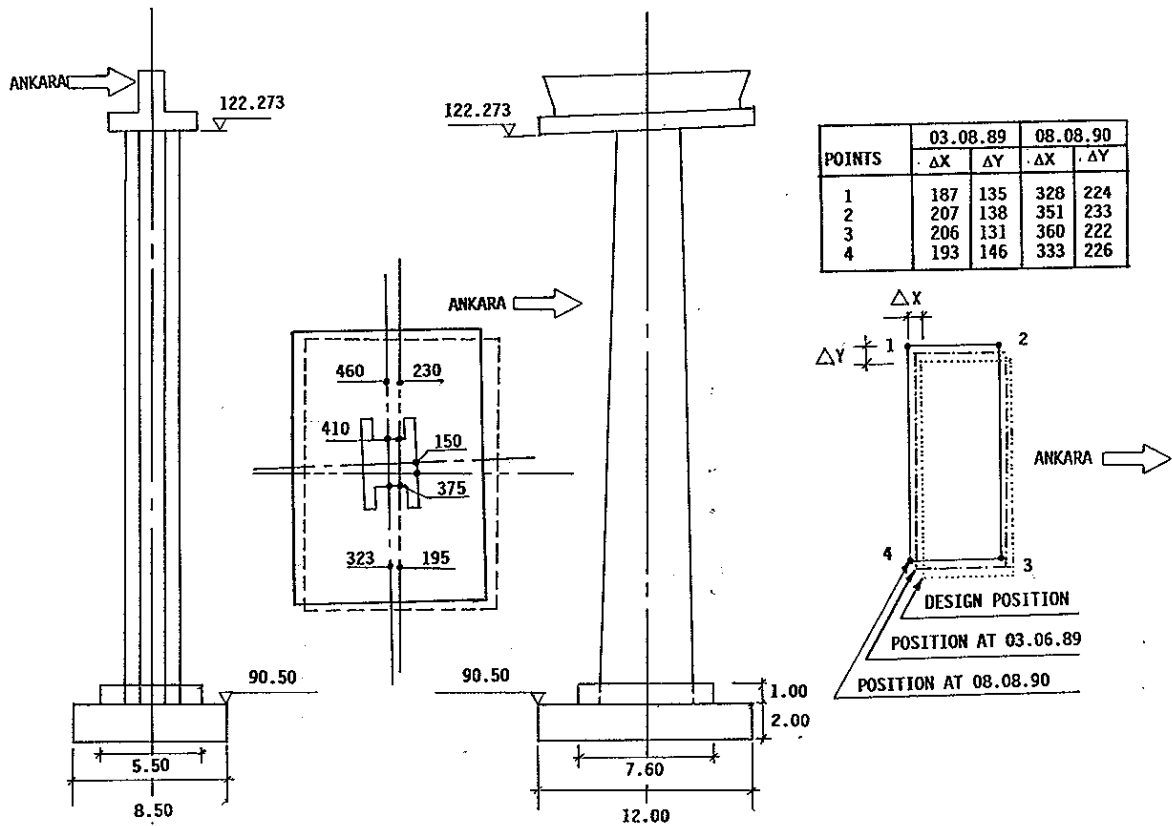
FIGURE 1 - MOVEMENT MEASUREMENTS FOR PIER 8R

Viaduct V5 (presently named as Mustafa İnan Viaduct) constructed by the Contractor Impregilo, Sezai Türkeş - Fevzi Akkaya Joint Venture (IGL-STFA JV) within the scope of Kınalı - Sakarya Motorway Project in Turkey. The pier 8R of the viaduct experienced lateral and vertical movements twice, first in June 1988 and second in August 1990. An extensive subsoil investigation, surface geology, monitoring, analysis and evaluation campaign performed between 1988 and 1990 to provide the stability of the eastern slope of the valley where pier 8R is located. The additional subsoil investigations indicated that the limestone covering the eastern slope on which the piers were located by shallow foundations in the original design is not stable bedrock but slope debris composed of limestone boulders above mudstone bedrock. The instabilities took place along the limestone debris / mudstone interface leading to movement of pier 8R. The other piers not constructed until the movement of pier 8R were also reevaluated and whole foundation design were reassessed.

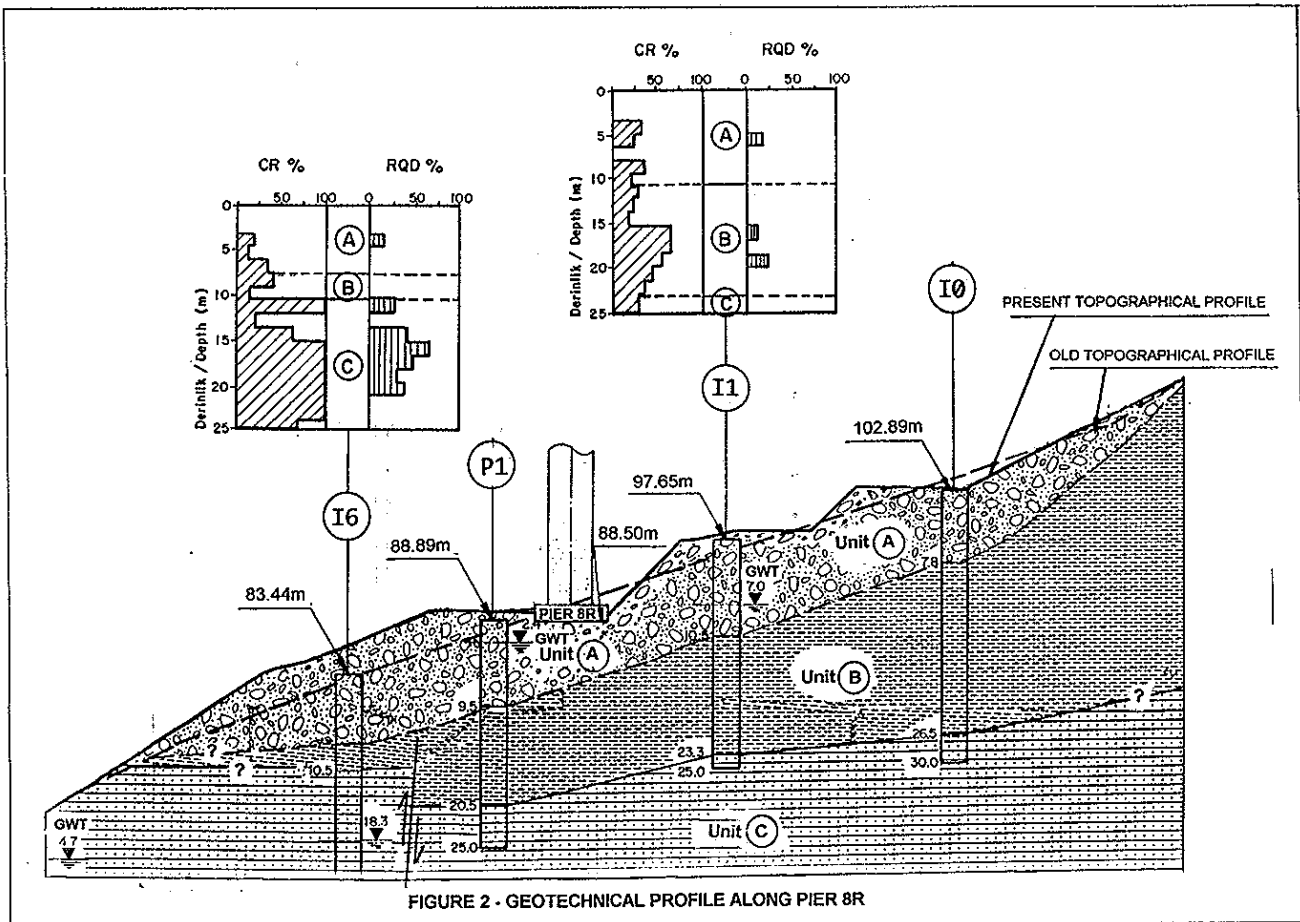
FIGURE 2 - GEOTECHNICAL PROFILE ALONG PIER 8R

Figure 2 presents the geotechnical profile along pier 8R in the direction of the resultant movement vector of the first movement. The pier 8R is located onto slope desbris (unit A) composed of limestone boulders within clayey matrix. Unit B easily differentiated during borings and also with increase in core recovery (CR) , RQD values is bedrock mudstone. Unit C is siltstone forming the valley bottom. The brief summary of these units is given below;

Clayey or crystallized limestone boulders mixed with clayey fine grained matrix, brown-beige and occasionally grey colored, in a loose form. The thickness vary between 0.0 to 15.65m with an average of 6.60m. Clayey matrix is classified as CL according to USCS. Core recovery (CR) varies between 10 to 100 % and rock quality designation (RQD) is 0 to 80 percent meaning very poor rock quality.

Claystone - siltstone of grey colored, in zone of extensive weathering brown colored clay zones of low plasticity (CL) very thinly bedded and extensively fissured. The thickness varies between 0.0 to 15.40m, CR is 0 to 100 percent and rock quality designation, RQD is 0 to 68 percent meaning very poor rock quality.

Siltstone, claystone and fine sandstone with clay interlayers (zones of weakness), burgundy colored thinly bedded. The starting depth is 0.0 to 31.0m, CR is 5 to 100 percent and RQD is 0 to 90 percent meaning very poor to poor rock quality.

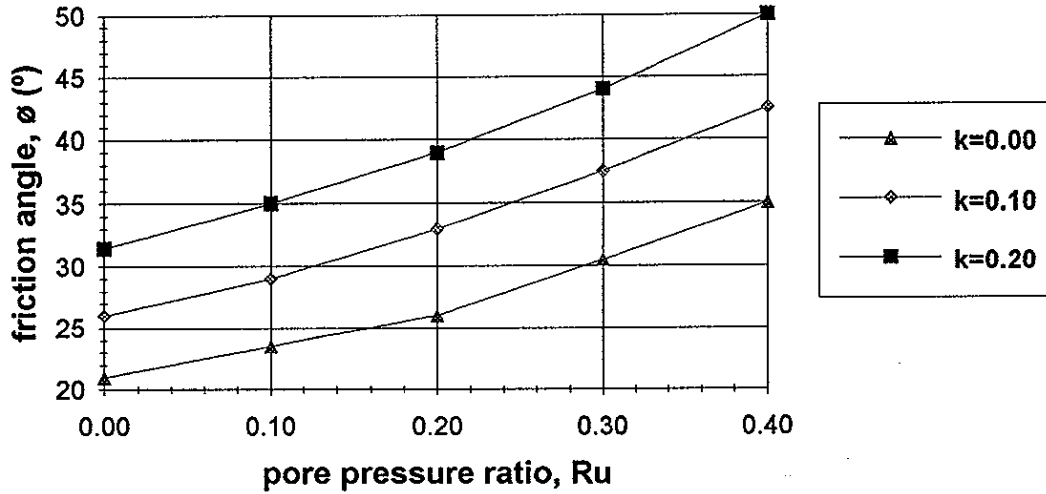
FIGURE 3 - Back Calculation Analysis for the topography of June 1988

The analysis for the loaded case (only the pier constructed) is presented in Figure 3. It is seen that for a possible range of values of pore water pressure ratio, $ru = 0.10$ to 0.20 , the required friction angle value for the analyzed slide surface under static conditions is $\phi_r = 23.7 - 26.6$ degrees. According to laboratory results, clay zones within the debris and mudstone resulted an average plasticity index value of $I_p = 15$. For this value, based on empirical relations developed by Kenney(1967), the residual friction angle is about $\phi_r = 24.0$ degrees.

As a result, an interface friction angle value of $\phi_r = 24.0$ is selected for use in the remedial design.

It is shown by the stability analysis that, increase in pore water pressure due to heavy rains with poor surface and subsurface drainage conditions and due to pier loading especially during minor earthquakes led to the instability of pier 8R and would cause the instability of other piers if the original design were not reassessed after the movement of pier 8R. For this purpose, a remedial design is developed mainly with below considerations;

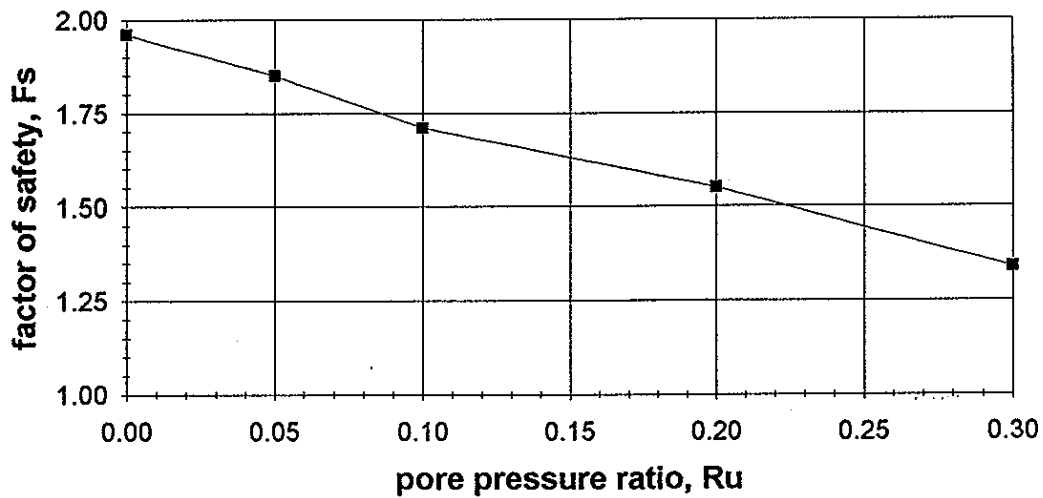
FIGURE 4 - Factor of safety under static conditions after remedial measure implementation ($k=0.00$, $\phi=24^\circ$)

Figure 4 presents the achieved factor of safety values against instability after the above remedial design measures implemented. A factor of safety of $FS = 1.85$ under static conditions and $FS = 1.01$ under a lateral earthquake coefficient of $k = 0.2$ is satisfied with the proposed remedial design considering that the pore water pressure ratio will be reduced to $ru = 0.05$ by proposed drainage system.

- * reduce gravity loads by means of regrading.
- * keep pore water pressures low by means of surface French drains and subsurface subhorizontal drains.
- * Eliminate external pier loading on the slope, by means of underpinning the constructed shallow foundation by micropiles.
- * Revise the design of not constructed piers and implement deep foundations by either large-diameter piles or micropiles considering the constructibility.
- * Following a strict construction scheme in order not to lead any instability during implementation of above recommendations.
