## TWO CASE STUDIES RELATED TO THE LANDSLIDE REMEDIAL DESIGNS

## 2. GEREDE-ANKARA AND ANKARA PERIPHERAL MOTORWAY Km 63+400 BUĞRALAR LANDSLIDE

### 3. GEREDE-ANKARA AND ANKARA PERIPHERAL MOTORWAY Km 154+650 LANDSLIDE

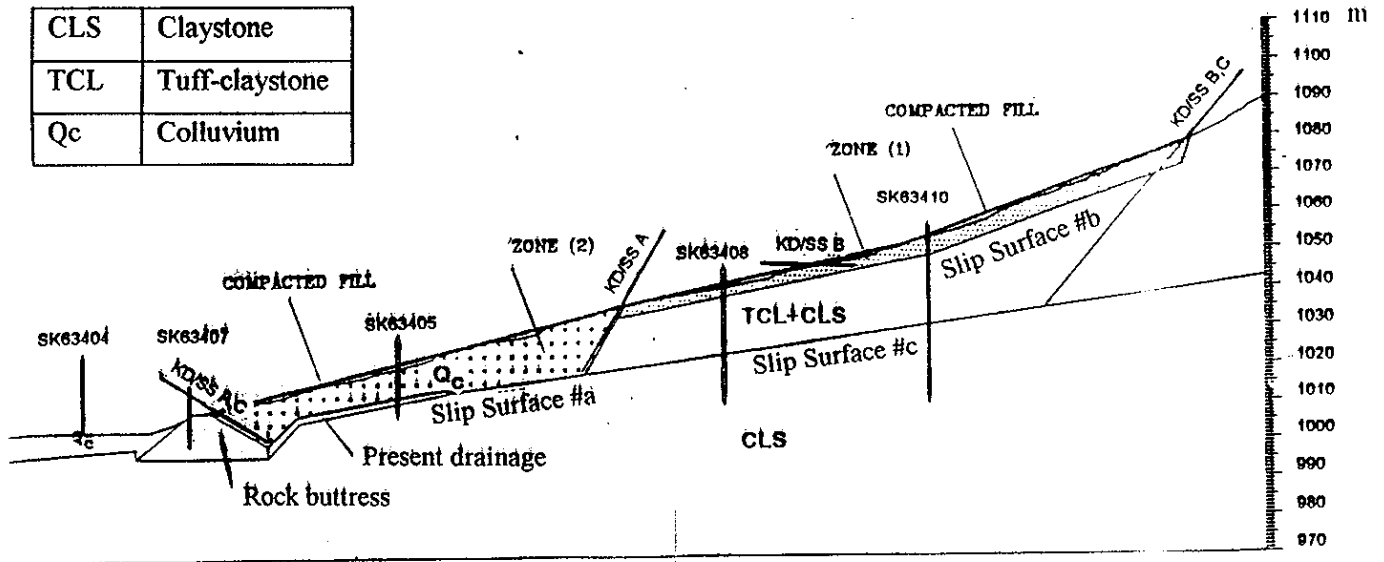
**FIGURE 1 KM 63+400 BUGRALAR LANDSLIDE - GEOTECHNICAL CROSS-SECTION**

The subsoil conditions are determined by the site and subsoil investigations. At the landslide location, there is colluvium on top, claystone (CLS) at the lower elevations of the slide area. At the higher elevations tuff-claystone (TCL) and below, claystone exist as the formations underlying the top colluvium (Qc) as could be seen in Figure 1. The thickness of the colluvium is less at the upper elevations. The slide is known to be along the colluvium/claystone interface (slip surface #a) at the lower elevations. However, slides may take place along the colluvium/tuff-claystone (slip surface #b) or tuff-claystone/claystone interfaces (slip surface #c) at the upper elevations. As a result, separate stability analyses are performed for these three different slip surfaces at each section. Circular slide surfaces are

Stability analyses for the observed case as of July 1992, revealed that (see Figure 1) the Section 1 is the most critical one and the lower colluvial material slipped into the previously excavated area down to the bedrock elevations may further slip even over the rock buttress (slip surface #a) (FS=0.89). The analysis at three sections for the upper colluvium (slip surface #b) illustrate that the stability of the upper colluvium is also critical (FS=0.75-0.92) and the slide may progress to the upper elevations. A deeper

instability along the tuff-claystone/claystone interface (slip surface #c) seems to be less probable (FS=1.33-1.58) compared to other shallower slip surfaces.

Recommended remedial works are, the removal of the lower parts of the landslide area defined with the area slipped in May 1990 up to the elevations where the colluvium gets thinner and tuff-claystone is encountered, down to the claystone bedrock (CLS) or to the previously constructed drainage layers. In addition, the slide area at the upper elevations are recommended to be excavated minimum 5.0 m or down to the tuff-claystone (TCL) for the purpose of removing the colluvial material. Finally, the complete excavated area should be filled with compacted material to the natural topographical levels. Additional subdrains are recommended in the lower excavated area before filling. The proposed construction scheme is summarized below:

- Excavate 5.0 or down to TCL at upper elevations (Zone 1, see Figure 1)
- Excavate down to bedrock CLS at lower elevations (Zone 2). Keep continuous record of probable movements with movement benchmarks installed at Zone 1.
- Construct subdrains.
- Fill the excavated parts with compacted material in a short period.
- Construct surface drains.

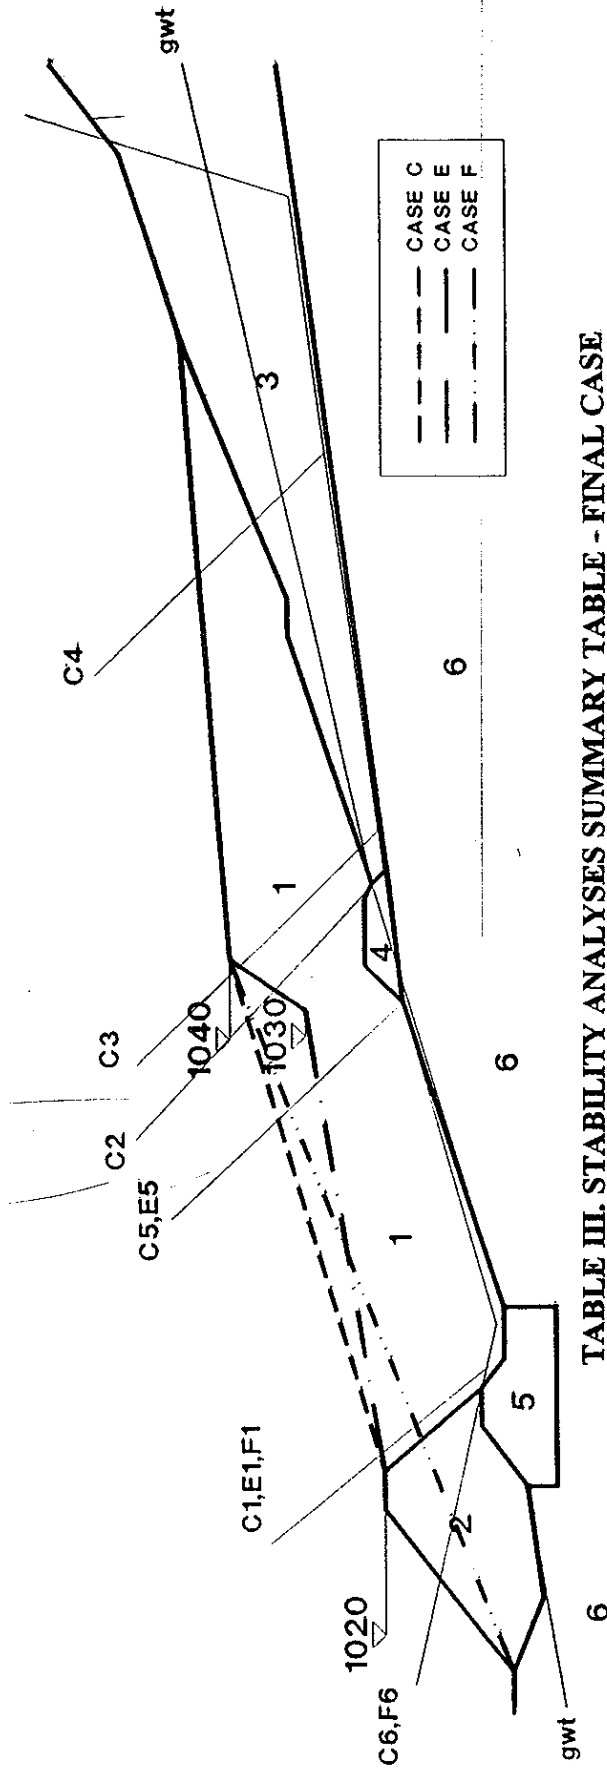
FIGURE 2. KM 63+400 LANDSLIDE - GEOTECHNICAL CROSS-SECTION  
FINAL CASE

As the last stage of the design works with consideration of the construction monitoring data, stability analyses are performed for seven (7) different backfilling configurations for both static and earthquake (0.2g) conditions. The geotechnical parameters and the numbers assigned to formations in the analyses are given in Table 1. BUGR C, BUGR E and BUGR F types provided satisfactory safety factors (FS) in term of stability (see Figure 2). BUGR F type was selected to be applied in the final design since this configuration required the least amount of earthfill material. Table III summarizes the stability analysis results for different slip surfaces and backfilling configurations. The design is implemented in the site and it has been determined by instrumental monitoring that the stability is achieved.

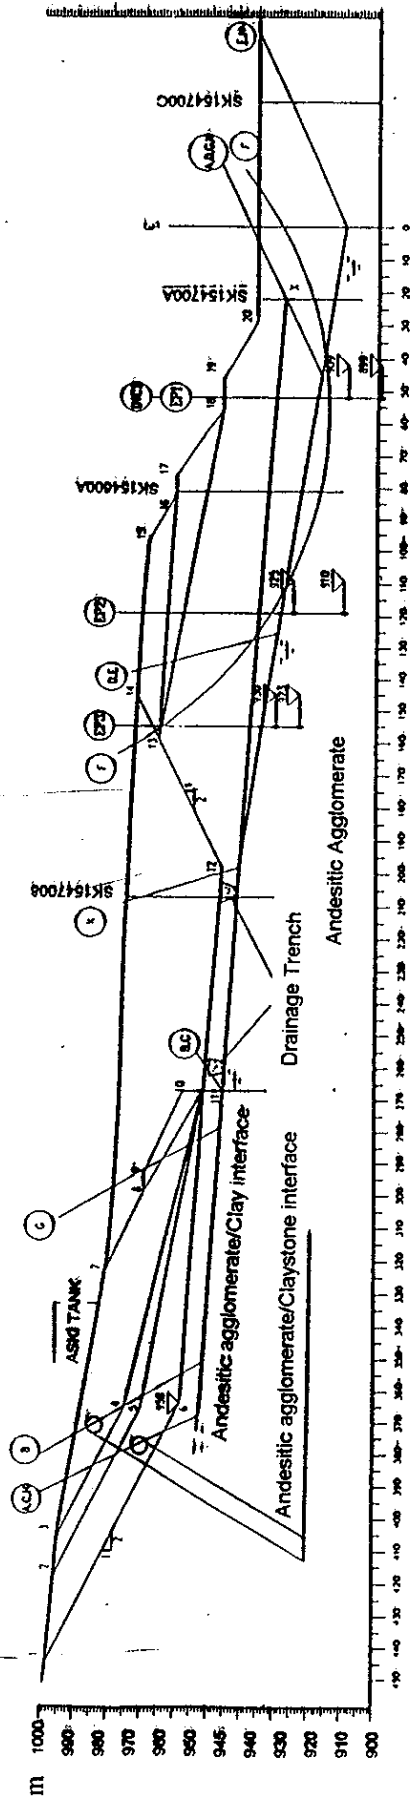
FIGURE 3. KM 154+650 LANDSLIDE - GEOTECHNICAL CROSS-SECTION

Back calculation analysis for the present case (defined by the points 1-2-3-7-14-15-16-17-18-19-20) to achieve a factor of safety of unity ( $FS=1.0$ ) for surface A-A yields  $\phi=9^\circ$  (K154A) for the andesitic agglomerate/clay-claystone interface under present high ground water conditions determined by the borings. Analysis through A-A for the present topography but for completely drained condition yield  $FS=1.547$  (K154DRY) under static conditions and  $FS=0.966$  (K154DR1) for earthquake coefficients of  $k=0.1$  (Çetinkaya, Durgunoğlu et al., 1993). This means that, if complete drainage of the landslide is somewhat achieved, the present geometry (natural) will satisfy the static factor of safety and will be very close to earthquake factor of safety without any excavation. Analyses for the other slip surfaces yielded

factor of safety values close to unity meaning that intermediate smaller size slides are also probable. Therefore, for such intermediate slide surfaces (partial slide mobilization) a somewhat less friction value is expected to be applicable within the andesitic agglomerate. A separate back-calculation is carried out to find the averaged friction angle value along the complete surface. This analysis (K154PN3) yielded average  $\phi_r = 15^\circ$  and some analyses are performed with this averaged friction value.

reasonable drainage measures (e.g. subhorizontal drains) for a complete drainage. Therefore, a deep excavation is considered to intersect the ground water level at the middle part of the landslide to reduce the driving forces. Drainage of the upper end lower parts of this deep excavation is proposed to be done by 5.0m-deep drainage trenches.

Various regrading alternatives including the removal of ASKI tank or keeping it with a piled retaining structure satisfying the design safety factor values of the motorway are studied. Table V and Figure 3 present the analyzed regrading geometries, the excavation quantities for every alternative and the calculated factor of safety values for various slide surfaces under static and earthquake conditions. As a result of all analyses, the excavation geometry defined by the points 1-7-11-12-13-16-17-18-19-20 is selected for the final design.

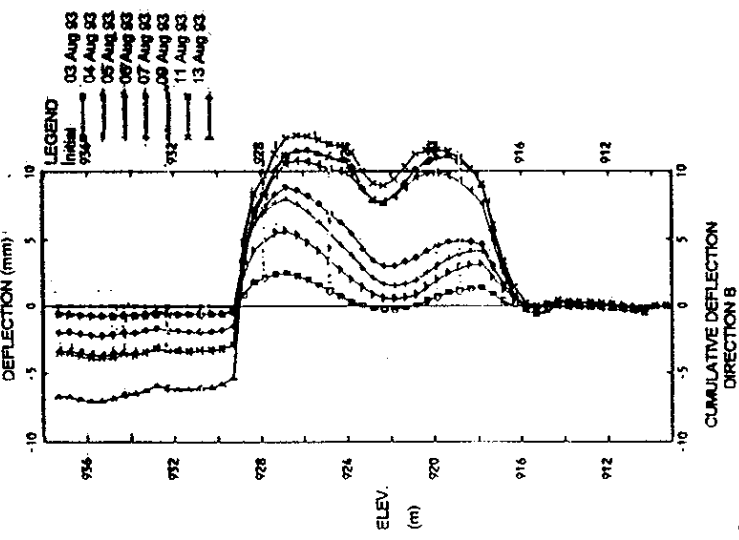
FIGURE 4. INCLINOMETER 1 READINGS

Instrumental monitoring works during the investigation and design stages consisted of inclinometers and surface benchmarks. The inclinometers are utilized to determine the depth of the sliding surface. For instance, the readings with time obtained from INC1 (see Figure 3), indicate that there is a movement at the elevation of 929 m as could be seen in Figure 4. Surface benchmark readings supported the inclinometers. Graphs developed from the surface benchmarks indicated the progress of the landslide in

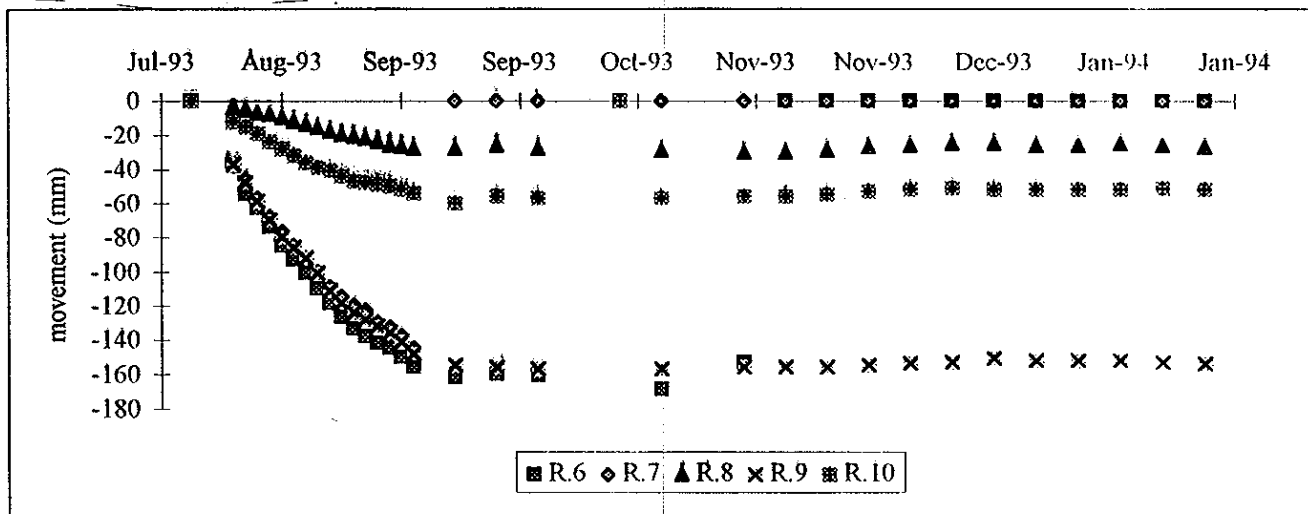
FIGURE 5. SURFACE BENCHMARK READINGS

time. As a short term measure based on the first available data it was proposed to perform some initial excavation at the top part of the landslide area in October 1993. A typical example is given in Figure 5. The surface benchmarks showed the tendency of slide to slowdown and stop after the excavation proposed in October 1993.
