# Soil Nailing Practice in İstanbul

C. Güney Olgun

Prof. Dr. H. Turan Durgunoğlu

Boğaziçi University, Civil Engineering Department, İstanbul, Turkey.

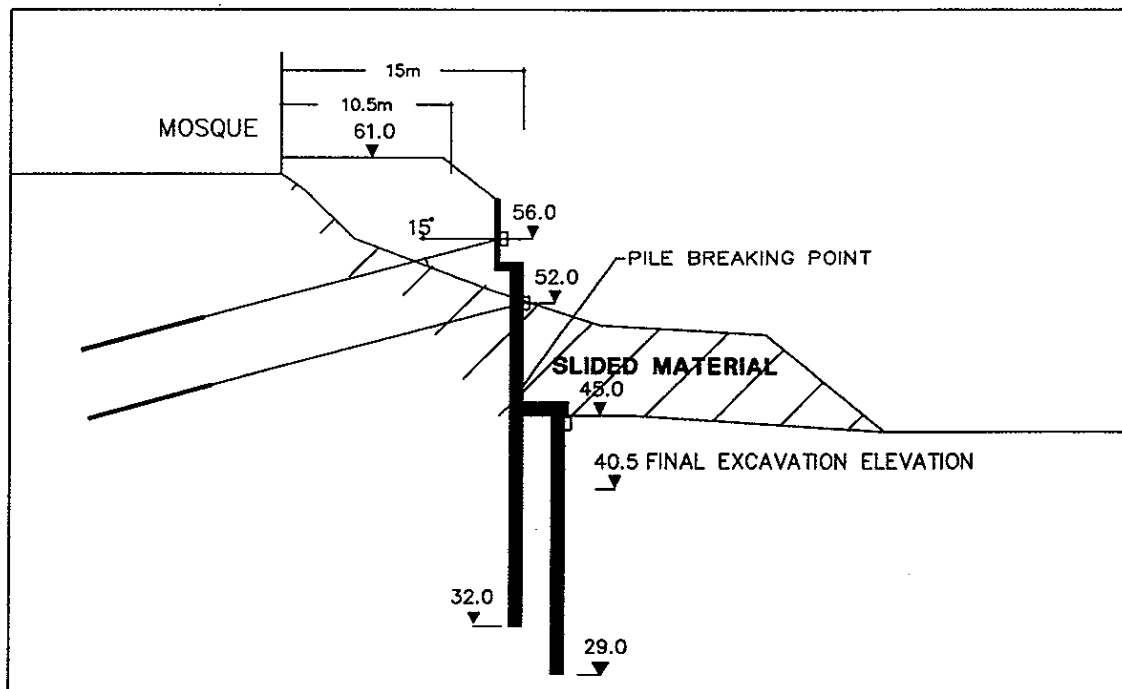
Figure 2. Typical Cross Section of Tieback Retaining Wall and Failure Geometry

The tieback wall was designed as the retaining system for the foundation excavation of a high rise hotel building. The retaining system consists of intersecting bored piles of  $\phi$  80 cm diameter, tied back with two rows of 20.0m long anchors. The initial ground elevation prior to excavation is 61.0m and the elevation of the final excavation base is 40.5m, creating a depth of 20.5m. A typical cross section and failure geometry is shown in Figure 2.

A sudden failure has occurred in the system described above when the excavation was at elevation 45.0m, corresponding to 16.0m depth. The failure covered the entire wall length of 80 meters, extending to 15.0m behind the wall. All of the anchors supporting the piled wall have shown to fail, some pulled out from the soil, some broken by the tendons. Resulting in damage to some neighboring structures and breaking sewage pipes and electricity cables, whole material in this zone slid into the excavation area.

It has been determined from the performed analyses that, even though the geotechnical parameters used in the design were valid, forces exceeding the allowable capacity are expected to develop on the elements of the tieback wall. Finally it has been determined that the intrusion of water and decomposition resulted an initial sliding movement. With this initializing movement, the shear strength of overconsolidated clay dropped from peak values to residual values and the stresses in the anchors increased to values exceeding the maximum capacity, resulting with failure (Durgunoğlu, 1995).
