FOUNDATION PROBLEMS OF KONYA ALAEDDİN MOSQUE AND IMPLICATION OF REMEDIAL MEASURES

H.T. Durgunođlu(1), T. Karadayılar(2), C. G. Olgun(1)

ABSTRACT

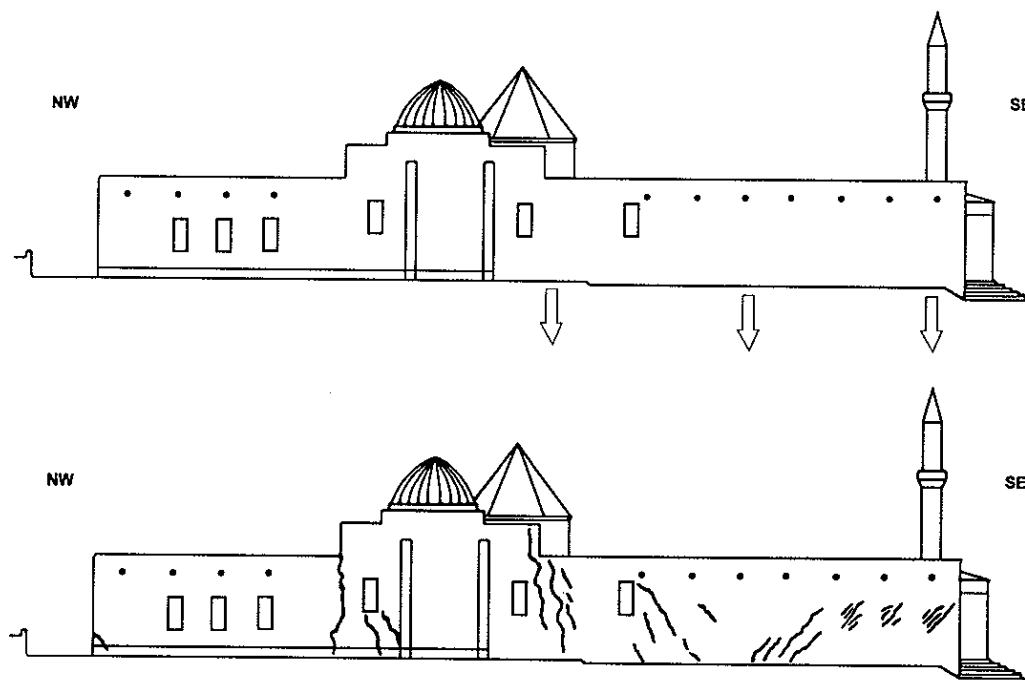
Figure 2. Settlement mechanism and resulting crack pattern along SW-NE wall

It has been determined from the evaluation of performed subsoil investigations and study of crack locations that the foundation of the structure has been subjected to differential settlements. The foundation subsoil has been observed to be highly decomposed due to leakage from the water reservoir located below the southern face and eastern corner of the mosque, which has been used for long years as municipal water storage. Finite element analysis has been performed to evaluate and model the deformation pattern expected to occur within the subsoil located below the mosque. The settlement mechanism and the resulting crack pattern along the northwest-southeast wall are shown in Figure 2.

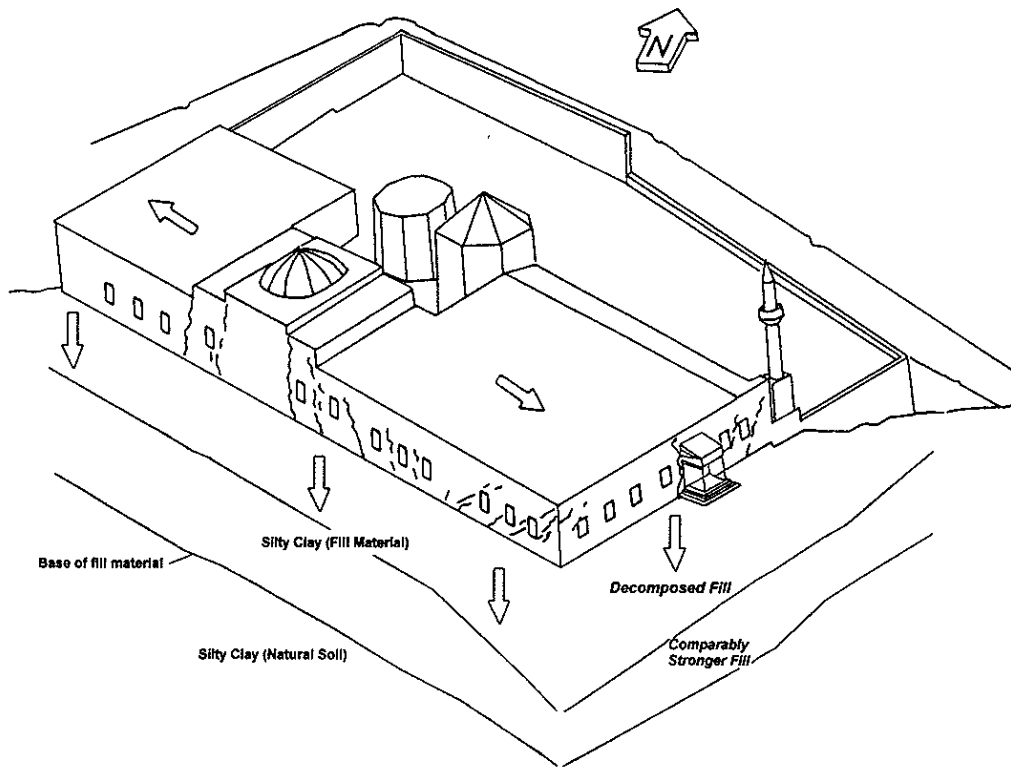
Figure 3. Schematical representation of three dimensional deformation pattern

It has been determined from overall slope stability analyses, no stability problems or lateral deformations are expected to occur at the Alaeddin Hill where the mosque is located. However the cracks in the structural elements have revealed that the mosque has been subjected to lateral deformations. The mechanism could be explained in a way that the vertical deformations in the foundation subsoil have

resulted in lateral deformations in the structure due to the behavior of the structural system. In one of the remediation attempts in the past the altar has been connected with tie beams and the roof at these locations has been replaced with reinforced concrete slab. This solution has prevented a possible local failure of the structure and however at the same time it has led the problem to spread to other sections/parts of the mosque. This situation has changed the behavior of the structure drastically. Due to the connections made along structural elements differential settlements in the foundation have resulted in lateral deformations in the structure. A schematical representation of the three dimensional deformation pattern is given in Figure 3.

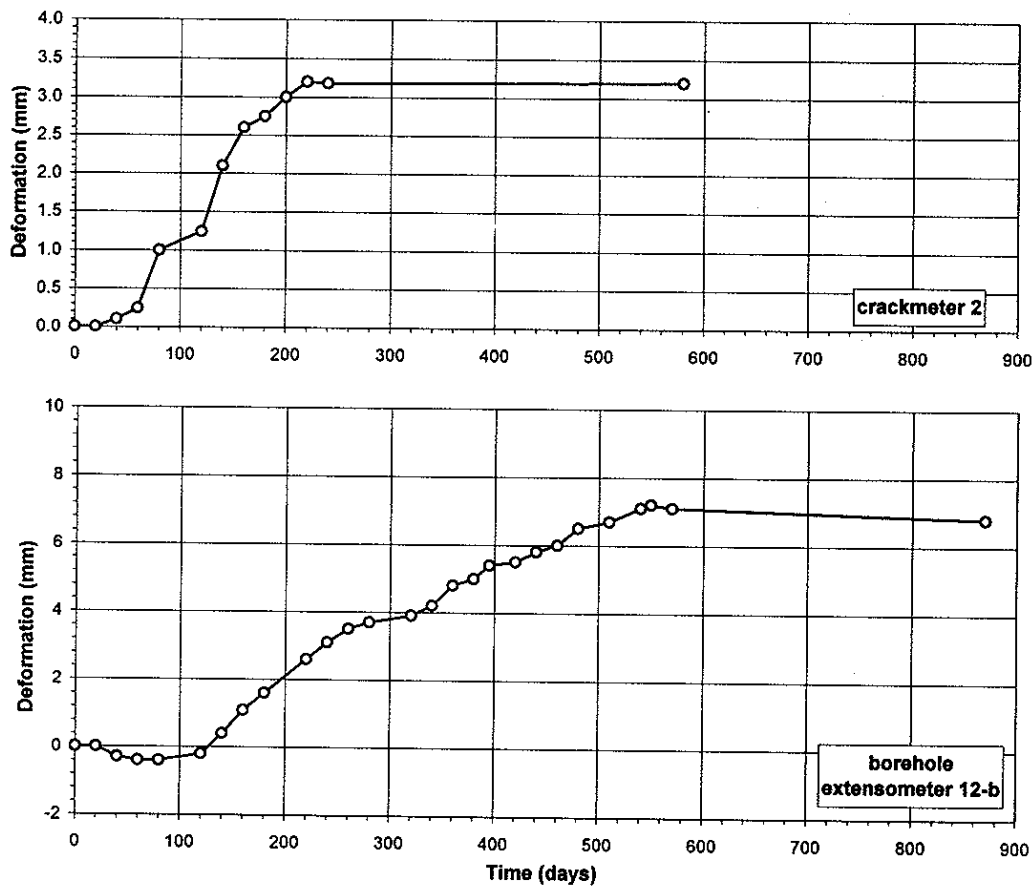
Figure 4. Deformation measurements from crackmeter and borehole extensometer

Deformation data obtained from a crackmeter and a borehole extensometer are given in Figure 4. The deformations observed both by crackmeters and extensometers are observed to diminish within time with the implementation of remediation works.

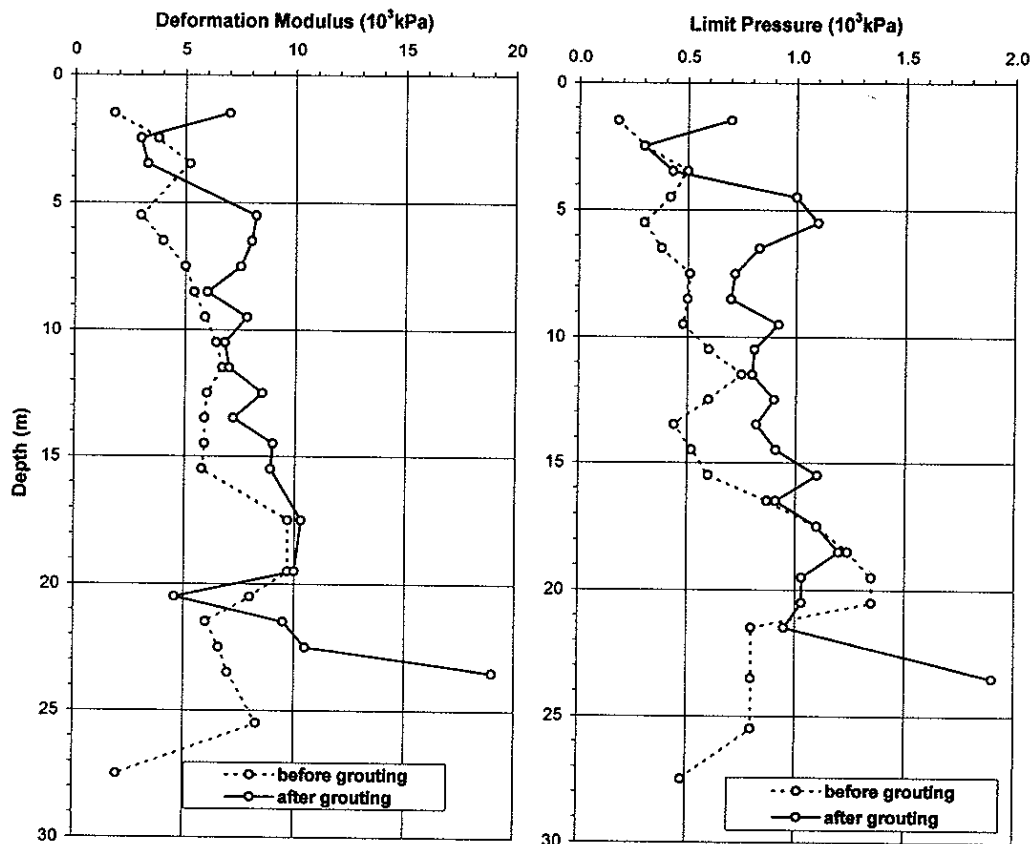
Figure 5. Assessment of degree of soil improvement from comparison of deformation modulus and limit pressure obtained from pressuremeter testing.

The results of pressuremeter tests are presented in Figure 5. The change of limit pressure and deformation modulus before and after improvement are shown in the figure. The increase in limit pressure is a measure of the increase in shear strength and the bearing capacity and the increase in the deformation modulus is a measure of decrease in the subsoil compressibility.
