# Case History for Ground Improvement Against Liquefaction Carrefoursa Shopping Center – Izmit, Turkey

H.T.DURGUNOGLU, Bogazici University, Istanbul, Turkey  
C. EMREM, Zetas Earth Technology Corp., Istanbul, Turkey  
T. KARADAYILAR, Zetas Earth Technology Corp., Istanbul, Turkey  
J. K. MITCHELL, Virginia Tech., Virginia Tech., Blacksburg, VA, USA  
J. R. MARTIN, Virginia Tech., Blacksburg, VA, USA  
C. G. OLGUN, Virginia Tech., Blacksburg, VA, USA

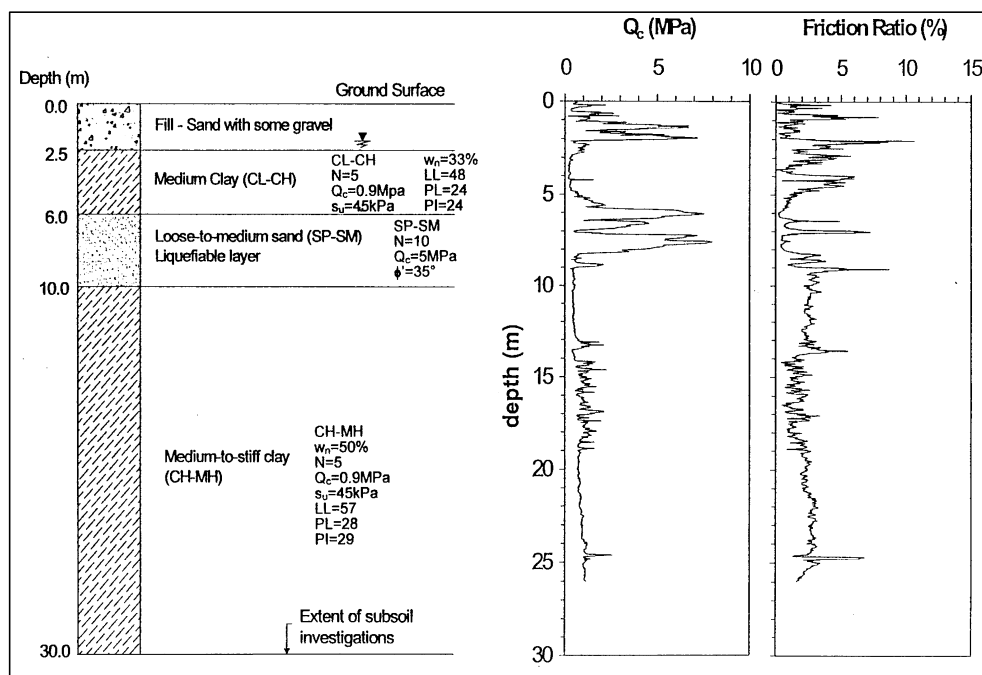
Figure 3. Typical geotechnical section

The site is underlain by a gravelly sand fill that extends from the ground surface to a depth of about 2.5 m. The fill is underlain by a medium clay stratum that extends from a depth of 2.5 m to 6.0 m. Below the clay, a stratum of fine silty sand is encountered at a loose-to-medium density. The thickness of this sand layer ranges from 4 m to 1 m across the site. Below the sand, is a layer of medium silty clay that extends from 10 m to a depth of more than 30 m, where the exploration was terminated. The ground water table was found within 2.6 m of the ground surface throughout the site. A representative geotechnical profile is shown in Figure 3.

For the analysis, peak accelerations in rock were estimated using attenuation relationships based on distance from the North Anatolian Fault. Magnitude was determined from prior seismological investigations that assumed a characteristic earthquake for the area. Peak accelerations at the ground surface were estimated by modifying the bedrock accelerations using the procedure given by Idriss (1998) for soft soil sites. Estimated cyclic stress ratios in the loose sand layer were found to be as high as 0.5 for the selected design ground motions of  $M=7.5$  and  $0.5g$ . It was estimated that the critical limit values of corrected tip resistance against liquefaction were  $q_{c1}=15$  MPa for clean sands and  $q_{c1}=11.5$  MPa for silty sands. To relate the fine content of soil layers with the friction ratio, the correlation chart suggested by Suzuki (1995) was utilized. From this method, the zones with  $R_f < 1\%$  and  $q_{c1} < 11.5$  MPa were considered liquefiable. Using the criteria, all CPT records were examined and the suspect zones were identified. It was found that a high potential for liquefaction exists for the sand stratum having an approximate thickness of 3.0 m throughout the site. Based on the results of these analyses, soil improvement was recommended to mitigate liquefaction risk.

The combination of jet grouting and pre-loading with prefabricated wick drains was found to be the most feasible solution for providing required foundation support in the soft clays as well as mitigating the anticipated liquefaction problem considering the locally available technologies. Jet grout columns 60 cm diameter were proposed for installation beneath the foundations as well as beneath the slabs-on-grade. The boundary of the preloading zone with prefabricated drains is shown in Figure 2. Magnetic extensometers were also installed at nine different locations within the pre-loaded zones to monitor settlements in the soft silty clay (Figure 2). Additional details of the soil improvement work for each area of the site are provided in the following sections.

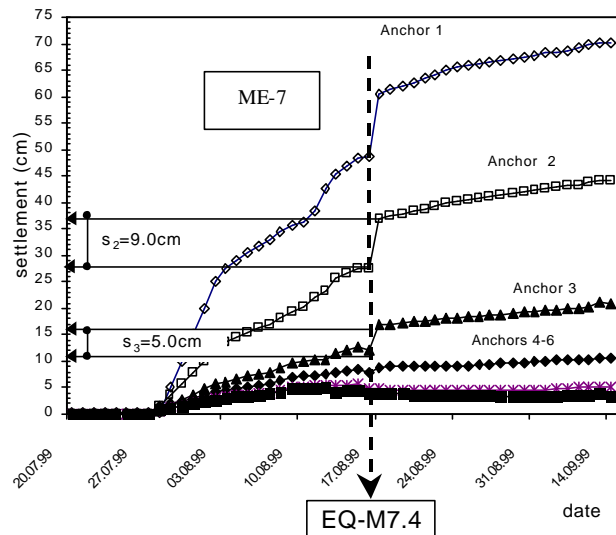
Following field inspection, it was concluded that the observed surface water originated from the wick drains due to earthquake-induced pore pressure build-up in the sand layer. Three settlement measuring devices were in place at Lot C zone during the earthquake. By comparing pre- and post-earthquake readings, the earthquake-induced settlement of the sand layer could be closely determined. A typical records from one of the three magnetic extensometers installed at Lot C, are presented in Figure 4.

Figure 4. Time dependent settlement readings from magnetic extensometer at Lot C

Each of the three installed magnetic extensometers consisted of five magnetic anchors installed at five-meter vertical intervals. During the quality control tests, 10 CPT tests were performed at Lot C area prior to jet grouting on 30/09/2001. CPTs 8, 9 and 10 were located closest to settlement columns 7, 9, and 8 respectively. The variation of tip resistance ( $q_c$ ), and friction ratio ( $R_f$ ) values with depth for a typical CPT data is shown in Figure 5. The estimated sand layer thickness for each CPT location ranged from 1.1 m to 1.5 m based on the soil classification procedure developed by Roberston (1988). To estimate the earthquake-induced settlement within the untreated sand layer, the difference between the settlement values recorded by anchors 2 and 3 were calculated. The elevation of anchors 2 and 3 do not correspond to the top and bottom of the sand layers (the anchors were installed in clayey and silty soil layers located about 2.5 m above and 1 m below the sand layer, respectively). Therefore, the estimated earthquake-induced settlements in the sand should be considered maximum values, as it is conceivable that a portion of the measured settlements may have occurred within the over- and underlying finer-grained soils. It is believed however, that the vast majority of the settlements measured between anchors 2 and 3 were from the sand layer. Based on this methodology, it is estimated that up to 4.0 to 4.5 cm of earthquake-induced settlement, corresponding to about 2.9 to 3.6% volumetric strain, respectively, occurred in the sand stratum.

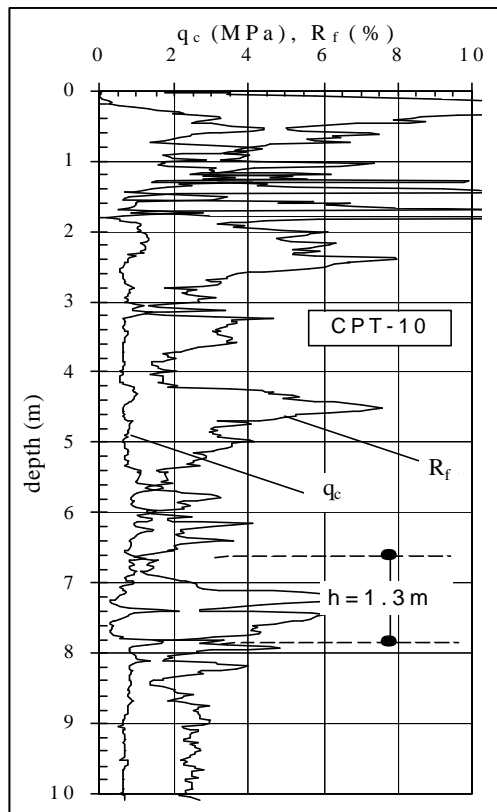
Figure 5. Typical CPT data from September, 1999 at Lot C, after the main shock, before the construction of jet grout columns

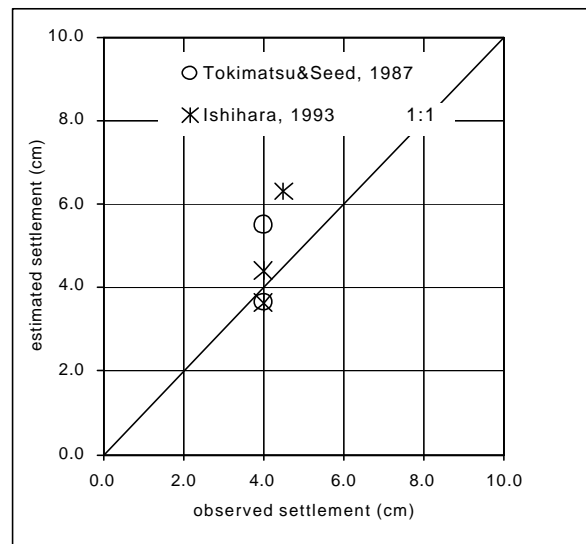
For purposes of comparison, existing settlement methods from the literature were used to assess predictive capability as determined by how closely they predicted the actual settlements. In using the CPT data for this purpose, the thin layer influence was considered as recommended by Robertson and Fear (1995), and a correction factor for cone resistance was also used in the calculations. Based on this methodology, Ishihara's procedure (1993), estimated about 4.8 cm of settlement. In order to compare the results from two in-situ tests, SPT blow count values obtained from boreholes made at Lot C are utilized and, Tokimatsu and Seed's procedure yielded an estimated average settlement of 4.6 cm. The results are summarized in Table 2 and plotted in Figure 6 for the purpose of comparison. For this site, it can be seen that both Ishihara's method utilizing CPT data and Tokimatsu and Seed's method utilizing SPT data provided close estimates for the observed settlements.

Procedure	Predicted Settlement (average value- cm)	Observed Settlement (average value- cm)
Ishihara (1993)	4.8	4.2
Tokimatsu and Seed (1987)	4.6

Figure 6. Comparison of estimated settlements

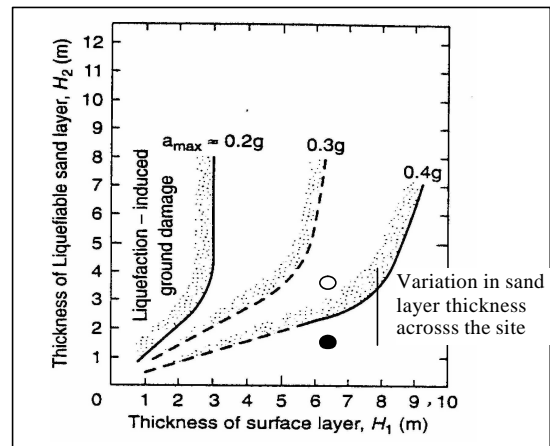
Figure 7. Conditions for occurrence and nonoccurrence of ground damage (After Ishihara, 1985; Adapted from Kramer, 1996)

m thick layer of "unliquefiable soil" overlays the 1.5 m thick liquefiable sand layer at Lot C section, non-occurrence of surface manifestation is expected according to Ishihara as shown with the full circle in Figure 7.

Considering that the liquefiable sand layer thickness reaches to 4.0 m, Carrefoursa site is still within the "no ground damage" zone as presented by the open circle on Figure 7. It is also informative to note that Lot C and partly parking structure sections were the only area at the complex that had not been improved with jet-grouted columns prior to the earthquake. All other areas had been improved with both primary and secondary grids of grouted columns to reduce liquefaction susceptibility. Based on the differences in performance between the unimproved and the adjacent improved areas, it has been demonstrated that the jet-grouted columns have been effective in reducing liquefaction
