Preliminary Findings from an Investigation of Improved Ground Performance During the 1999 Turkey Earthquakes

James R. Martin II¹, C. Guney Olgun¹, James K. Mitchell¹,
H. Turan Durgunoglu², Canan Emrem³

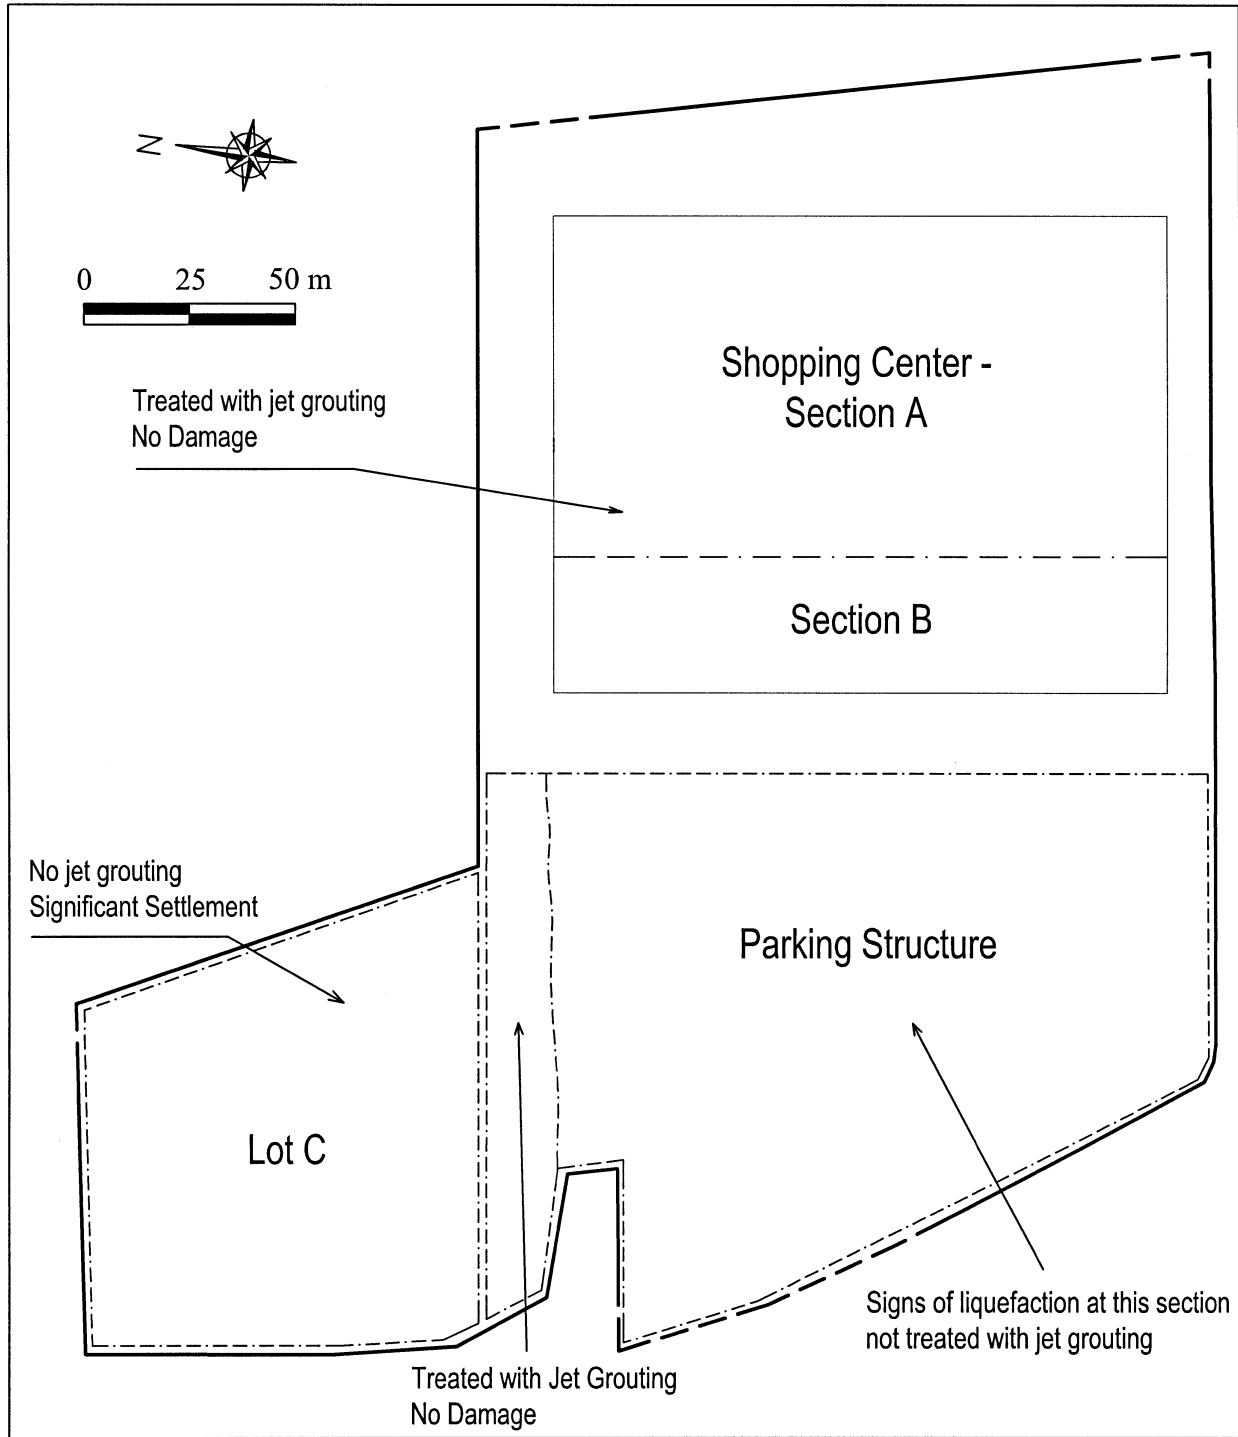
Figure 2. Carrefour Shopping Center – site plan

the supermarket building and no noticeable settlements or ground damages were observed anywhere at the site except in the untreated portion of the Parking Structure area and Lot C.

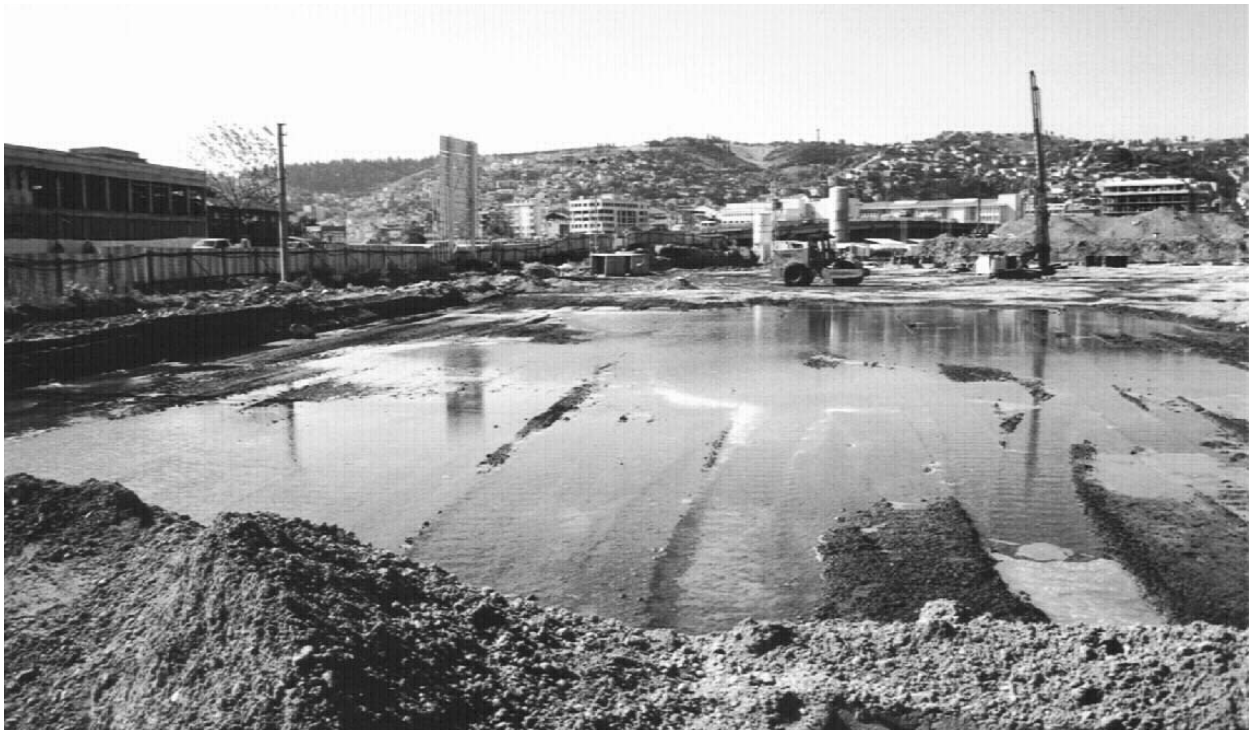
Site personnel reported that the untreated portion of the Parking Structure area was inundated with about 7 to 10 cm of water that temporarily ponded on the ground surface the morning following the earthquake as shown in Figure 3. It may be remembered that wick drains were installed in this area, and a surcharge fill was removed prior to the earthquake. Field inspections determined that the water originated from the underlying soil deposit via drainage through the wicks. It is fortuitous that settlement-measuring devices were in place at Lot C during the earthquake. By comparing pre- and post-earthquake readings from within the soil profile, the earthquake-induced settlement of the sand layer could be closely estimated. It was found that 8.0 cm of settlement occurred in the 2 m-thick loose silty-sand layer, presumably due to pore pressure build-up and subsequent reconsolidation via drainage through the wicks. It is also possible that the wick drains provided partial drainage during the earthquake, although the silty sand is not expected to be free-draining. To our knowledge, this type of earthquake-induced settlement measurement is unprecedented and provides an opportunity to better understand saturated sand behavior under strong ground shaking. Also, the measured settlement of 8.0 cm in the loose sand layer compares well with the 7 to 10 cm of water ponding on the surface, as the amount of extravasated water should be reflective of the volumetric strain induced in the sand layer. It is important to note that no surficial ground disruptions, such as sand boils, occurred at this location. The wick drains are thought to have prevented liquefaction and/or provided efficient drainage of the sand during reconsolidation, although significant settlements still occurred.

Figure 3. Ponding of water at portions of the parking structure area that were not yet treated with jet grout columns, Lot C under the preload fill is visible at the back – photograph taken the morning after the earthquake from the site border looking north

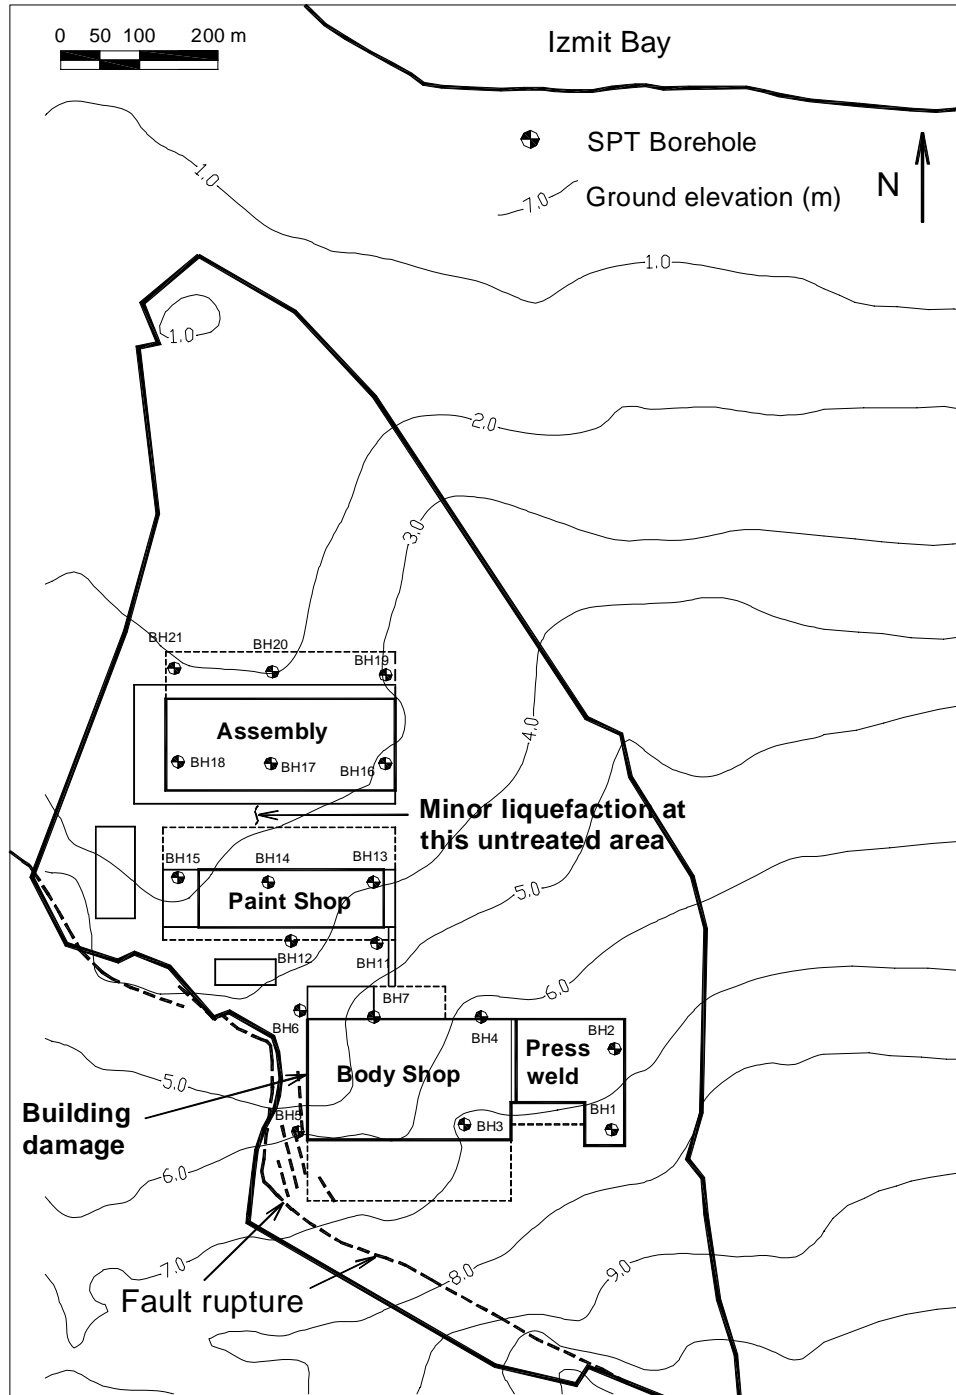
Figure 5. Ford plant – site plan

Following the earthquake, a visual inspection of the plant revealed significant earthquake-related damages. The most prominent observation was that the entire site underwent a global subsidence of about 2.5 m due to movements associated with the surficial fault rupture passing along the western plant boundary. The Body Shop, located closest to the fault rupture, underwent differential foundation movements of about 1 m, resulting in severe structural damage to the building. No signs of obvious liquefaction were found at the building and it is presumed that most of the damage was fault-related; however, it is possible that liquefaction-related phenomena may have played a role. The Body Shop is being demolished and re-built.

Small sand-boils and limited settlements, indicative of minor liquefaction, were observed in an open area between the Assembly Building and Paint Shop where the soils were not treated. Lateral spreading was observed along the waterfront in the general vicinity of the plant, but no spreading or any other signs of liquefaction were observed anywhere at the site. The liquefaction appears to have been confined to areas where the soils were unimproved. This difference in behavior between untreated and treated ground suggests that the soil treatment was effective in reducing liquefaction-related damages.
