SOIL IMPROVEMENT WITH JET-GROUT COLUMNS: A CASE STUDY FROM THE 1999 KOCAELI EARTHQUAKE

H. Turan Durgunoglu

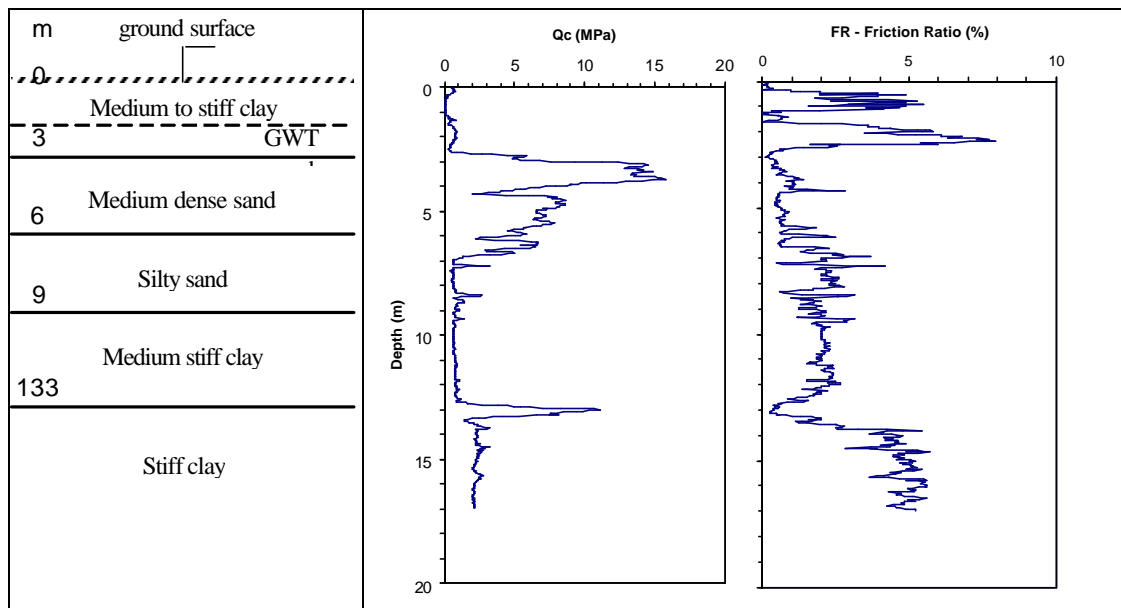
extends from the ground surface to a depth of 3 m. Below the clay is a stratum of clean sand of medium density that extends from 3.0 m to a depth of 6.0 m. From 6.0 m to 9.0 m, a medium-dense silty sand layer is encountered. Below 9 m, a stratum of stiff-to-hard clay is found that extends to the bottom of the boring at a depth of 32.0 m. In some borings for this area, a medium dense sand layer was also found between the depths of 24 m and 27 m. The water table was found at a depth of 1.5 to 2 m. The PM3 soil profile can be considered representative of the entire plant site; however, specific soil data for the other structures were also available.

Figure 4. Subsoil Profile at the location of PM3 Building

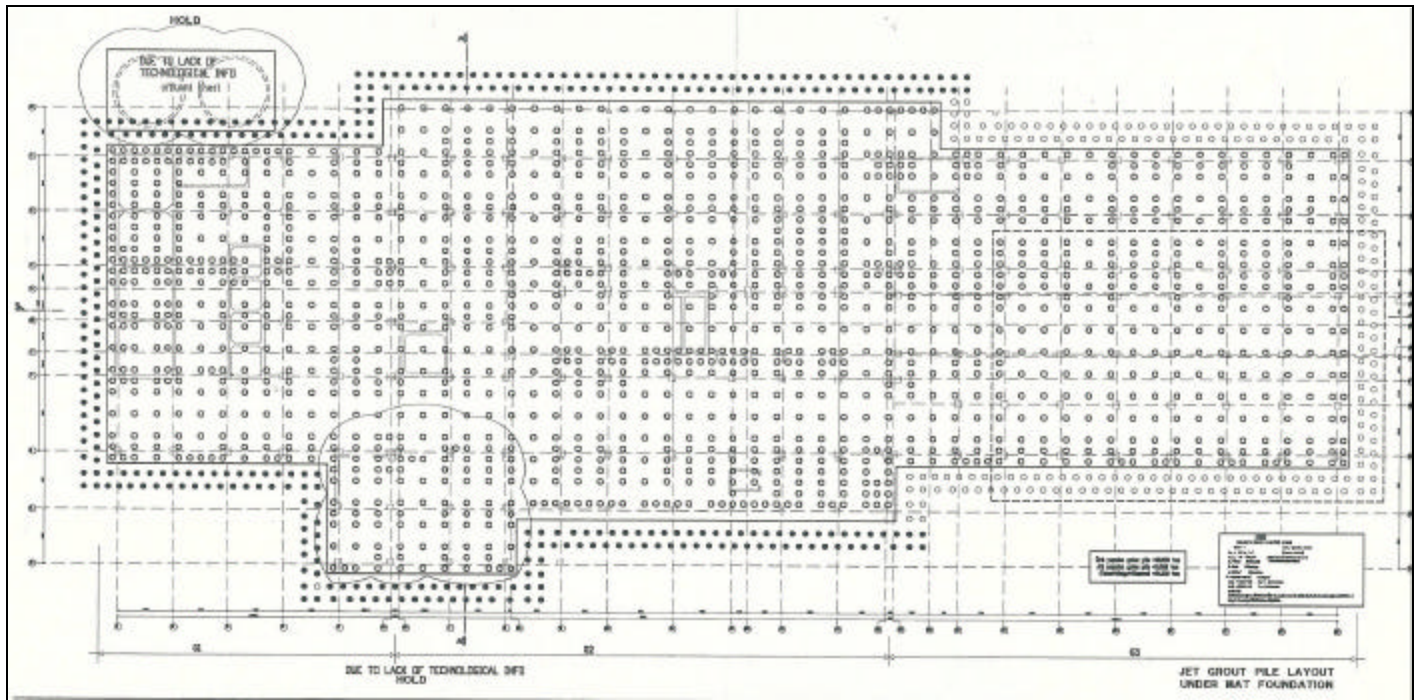
The PM3 Building, being constructed at the time of the earthquake, is supported by a reinforced-concrete mat foundation. To improve the soils in this area, jet-grouted columns 12 m-long and 0.6 m in diameter were installed beneath the mat in a rectangular grid pattern. Center-to-center column spacing ranged from 1.2 to 2.4 m corresponding to an average area replacement ratio of $a_r=0.10$. Two additional rows of grouted columns were constructed around the perimeter of the building to provide additional safety against soil liquefaction, acting as containment structure to reduce the shear induced lateral displacements. These columns were 8.0 m long and spaced at 1.4 m center-to-center. The allowable axial capacity of each grouted columns under the mat foundation was estimated as 600 kN. The capacity was verified by means of pull-out tests on selected columns. Grout columns spacing and diameters were selected mainly on the basis of foundation loads, as no detailed analyses were made to modify the column patterns for liquefaction prevention: however, it was assessed at the time of the original design that the jet-grouted columns, with certain area replacement ratio and much higher stiffness compared to original soil, would significantly reduce liquefaction-related problems (Ozsoy, 2002). The lay-out of jetgrout columns at the location of PM3 Building is given in Figure 5.

The estimated cyclic shear stress ratio reduction factor K_G is about 0.27 for $a_r=0.10$ and 0.33 for $a_r=0.07$ for G_r value of 30 according to Ozsoy and Durgunoglu (2003). In other words, as a result of applied configuration and parameters, about 70% of the earthquake induced shear stresses was carried by the higher modulus jet-grouted columns.

Figure 5. PM3 Building Jetgrout Lay-out Plan

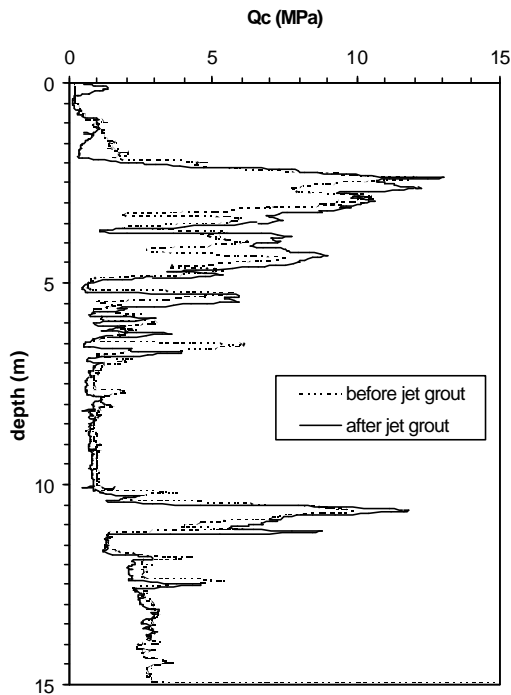
Following jet grouting, CPTs were performed in the areas between the columns. Comparison of CPT soundings before and after jet-grout columns indicate that no significant increase in penetration resistance was achieved as seen in Figure 6, as would be expected, as the jet grouting

process installs reinforcing columns but does not densify the in-situ soil. Comprehensive study was performed on the samples taken from the soilcrete by means of compression testing. Both the compressive strength and the modulus of the core samples taken from the soilcrete were measured. The measured average compressive strength value of soilcrete was 3.0 MPa and the shear modulus value was 2700 MPa. The modulus ratio, G_r of soilcrete to unimproved soil according to Ozsoy and Durgunoglu (2003) was in the order of 30.

Figure 6. Comparison of CPT tip resistances before and after jet grout column construction

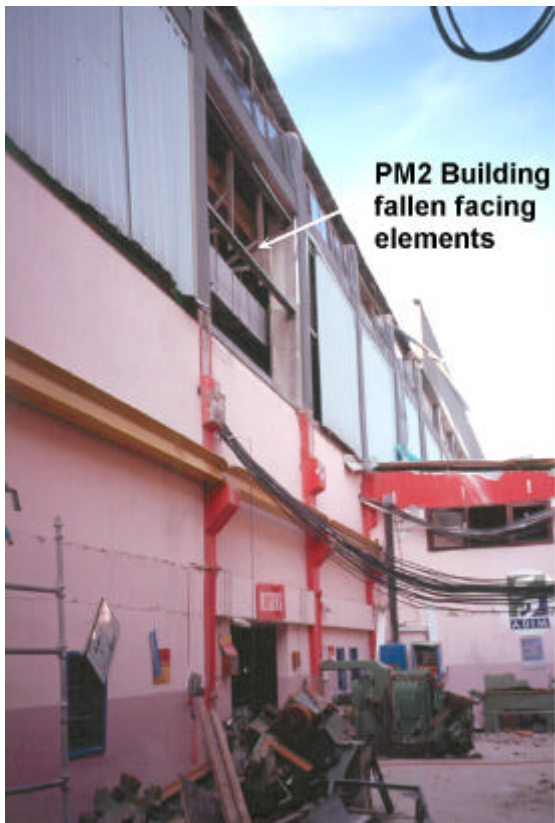
The shaking levels at the Ipekkagit plant site reached about 0.3g during the 1999 Kocaeli Earthquake (M7.4) as estimated from nearby recordings and distance to the zone of energy release. Following the event, a visual inspection of the plant revealed no major earthquake-related damages. All facilities remained operational during and after the earthquake. Only minor structural damage occurred in one of the older buildings (PM2 Building) where a heavy concrete facing element fell off the exterior of the building, and an interior reinforced-concrete column developed cracks about 1 cm-wide. The external damage to the building is shown in Figure 7. No structural damage occurred anywhere else at the plant. The foundation soils for the PM2 building were not improved; therefore, it could be stated

that minor structural damage occurred at an area where the foundation soils were not improved.

Figure 7. Photograph showing structural damages at PM2 Building due to falling of exterior panel.
