High-Modulus Columns for Liquefaction Mitigation

James R. Martin II, A.M.ASCE¹; C. Guney Olgun, S.M.ASCE²; James K. Mitchell, Hon.M.ASCE³; and H. Turan Durgunoglu, M.ASCE⁴

Abstract: This paper presents the performance of a shopping complex in Turkey where the soils were improved with jet-grout columns and preload fills and subjected to the 1999 Kocaeli Earthquake ($M=7.4$). Under construction at the time of the earthquake, the Carrefour Shopping Center covers an area of 55,000 m² and is founded on shallow footings, mats, and slabs-on-grade that rest on soft, saturated alluvial sediments consisting of clays, silts, and sands. High-modulus columns constructed by jet grouting were installed at close-to-moderate spacings to reduce anticipated static settlements in the clays and mitigate liquefaction in the sands. The site was subjected to a peak acceleration of approximately 0.2g during the earthquake. Grouting had been completed for about two-thirds of the site when the earthquake struck. Following the event, a field reconnaissance found stark contrast between the performance of the improved and unimproved sections. The jet-grout-treated areas suffered no apparent damage, whereas th

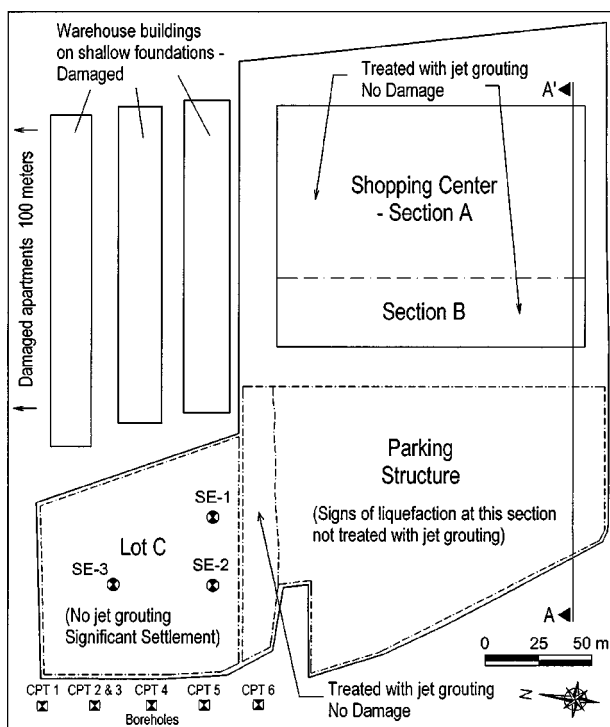
Fig. 2. Site plan of Carrefour Shopping Center showing improved area and unimproved areas along with observed earthquake damages. Locations of post-earthquake soil investigations are also indicated.

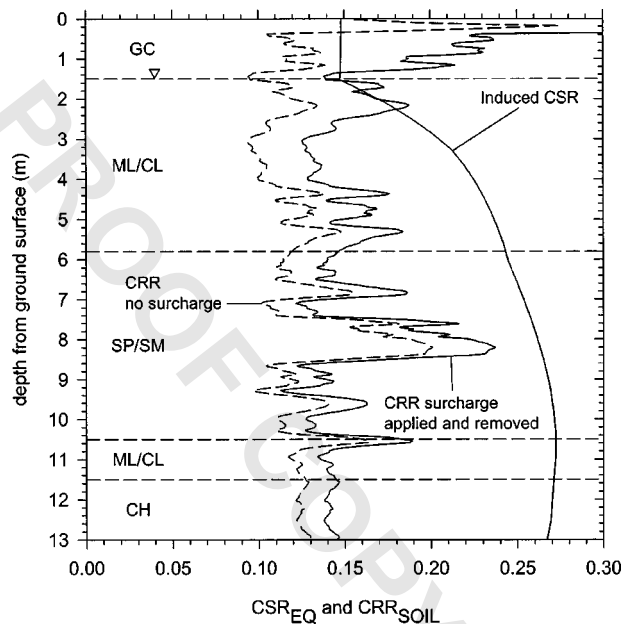
Using CPT data, an average CRR of about 0.14 was estimated for the upper 11.5 m of the profile, as indicated by the dotted curve shown in Fig. 6. The curve accounts for the estimated fines content of each layer and is representative of conditions where no improvement was used. (The solid CRR curve shown in the figure illustrates the effect of improvement due to surcharge fills and will be discussed later.) As shown, the CSR is higher than the CRR throughout most of the profile, with the factor of safety against liquefaction ranging from about 0.5 to 0.7, and averaging about 0.6. This factor of safety typically indicates liquefaction accompanied by flow of water to the surface (sand boils) and significant settlements. Because the soil profile is mixed with pockets of sandy and clayey material and the pertinent strata vary in thickness and fines content across the site, the liquefaction is expected to be erratic. Ishihara's procedure (1985) was used to

Fig. 6. Liquefaction analysis results for representative soil conditions at Carrefour site prior to jet grouting. Dotted cyclic resistance ratio curve is for nonsurcharged areas; solid curve indicates increased liquefaction resistance from OCR effects associated with 3.3-m surcharge fill application and removal in the Parking Garage area.

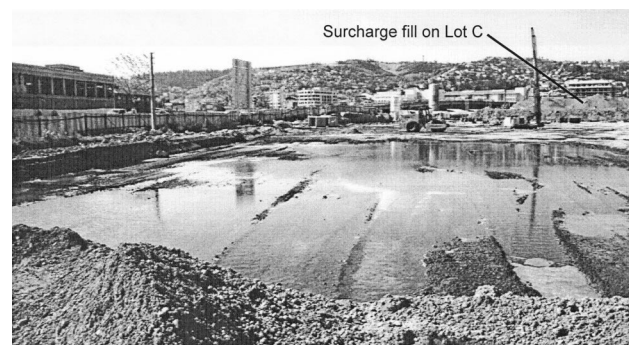
Fig. 7. Ponding of water (7–10 cm deep) at untreated portions of parking structure that was expelled through wick drains following M7.4 Kocaeli Earthquake. Lot C, under surcharge fill, is visible at right rear of inundated area. Photograph taken the morning after the event.

The parking structure had not yet been built and jet-grout column installation was just beginning in this section when the earthquake occurred. Wick drains had been installed and the area surcharged with a 3.3-m-high fill that had been removed a few weeks before the earthquake. In contrast to the supermarket area, significant settlements occurred in this section. Site personnel reported that the nongROUTED portion of the parking structure area was inundated with 7–10 cm of water that ponded on the ground surface the morning after the earthquake, as shown in Fig. 7. During field reconnaissance, it became apparent that the water originated from the underlying soil deposit via drainage through the wicks. The magnitude of the settlement should have equaled the depth of water ponding on the surface, as the amount of expelled water is expected to be reflective of the earthquake-induced volumetric change that occurred in the soil profile. The fairly uniform depth of water suggests the settlement was uniform. No sand boils were observed anywhere in the area.

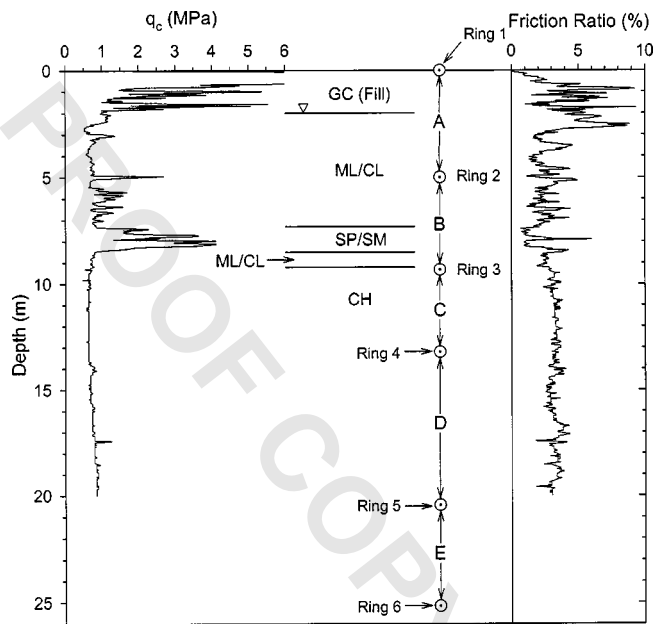
Fig. 8. Soil conditions near SE2 in Lot C (unimproved soils) where settlements were measured. Fig. shows positions of settlement rings, soil layers A–E, and CPT results.

Similar to the parking garage area, Lot C was surcharged with 3.3 m of fill and wick drains were installed. The fill was still in place at the time of the earthquake (see fill in background of photograph in Fig. 7). To monitor settlements in the clayey soils due to the fill, settlement extensometers were installed at three locations in Lot C (SE1, SE2, SE3 in Fig. 2). The extensometers consisted of plastic guide pipes 5 cm in diameter with a set of magnetic rings that slid down along the outside of the fixed-in-place pipes as the soil profile settled. The positions of the magnetic rings were measured daily to determine the settlement at specific elevations within the soil profile. It is fortuitous that these devices were in place during the earthquake. Fig. 8 shows the elevations of the six settlement rings installed at SE2, and Fig. 9 shows the measured settlement versus time. The behavior at this location is representative of that observed at the other extensometers.

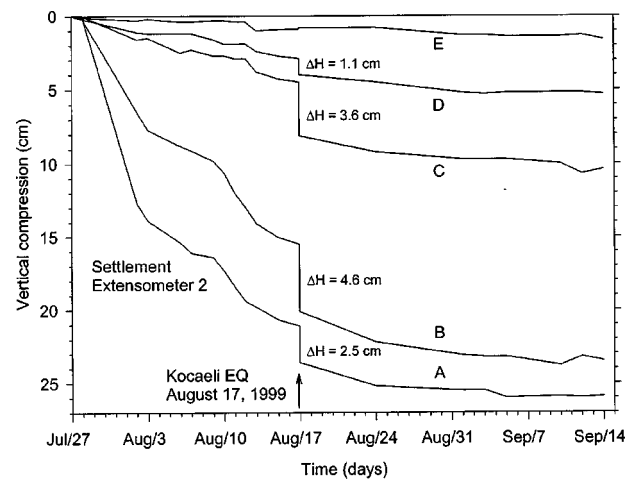
Of particular importance is the sudden offset in the curves following the Kocaeli Earthquake on August 17, 1999. By comparing pre- and post-earthquake readings, the settlements associated with the earthquake could be estimated for each ring location. And by subtracting the settlement of a given ring from that of the ring located immediately above, the settlement attributed to the portion of the soil profile situated between the two rings could be obtained. As such, the profile was divided into five sections (layers A through E) and the earthquake-induced settlement of

Fig. 9. Settlement versus time for Layers A–E (shown in Fig. 8) under surcharge fill in Lot C. Note abrupt offset in curve on 17 August 1999 that indicates settlement induced by Kocaeli Earthquake (ΔH values).

each layer is noted in Fig. 9. The earthquake-induced settlements indicated in the figure occurred in less than 24 h, the elapsed time between the reading of the instruments the day before and morning after the earthquake. As can be seen, the total earthquake-induced settlement of Lot C was about 12 cm, and it was surprising that a significant percentage of the settlement was attributed to the clayey and silty strata. Layer A, which contains 2 m of medium dense unsaturated fill (GC) and 3 m of soft saturated ML/CL material, experienced a settlement of 2.5 cm. The gravely fill is not believed to have contributed significantly to the measured settlements. Layer B contains 1.5 m of cleaner SM material and 3 m of the ML/CL soil. The measured settlement in this layer was 3.5 cm. The average apparent volumetric strain in these upper layers was about 0.8%. Unexpectedly, the balance of the settlement, nearly 6 cm, was associated with the underlying materials classified as CH (layers C, D, and E) and reaching to a depth of more than 20 m, especially layer C, which underwent 3.6 cm of settlement (apparent volumetric strain of 0.9%). A definitive explanation as to how these fine-grained soils could have experienced such rapid settlements cannot be given at this time. It is suspected that the settlements are due to earthquake-induced strength loss/softening and subsequent constant-volume shearing distortions due to the overlying fill. It is possible, too, that the instruments malfunctioned and some of the settlement readings were in error; however, we have not yet been able to conceive of how any such malfunctions could have occurred.
