# A case history of jet grout column application in Turkey

**ABSTRACT:** This paper briefly reports the case history of a large jet grouting application in Turkey. The execution of jet grouting was for the foundation improvement against settlement of a 4-storey shopping center that includes 1-storey basement in capital city, Ankara. The paper describes the design, construction and performance of the jet grouting process.

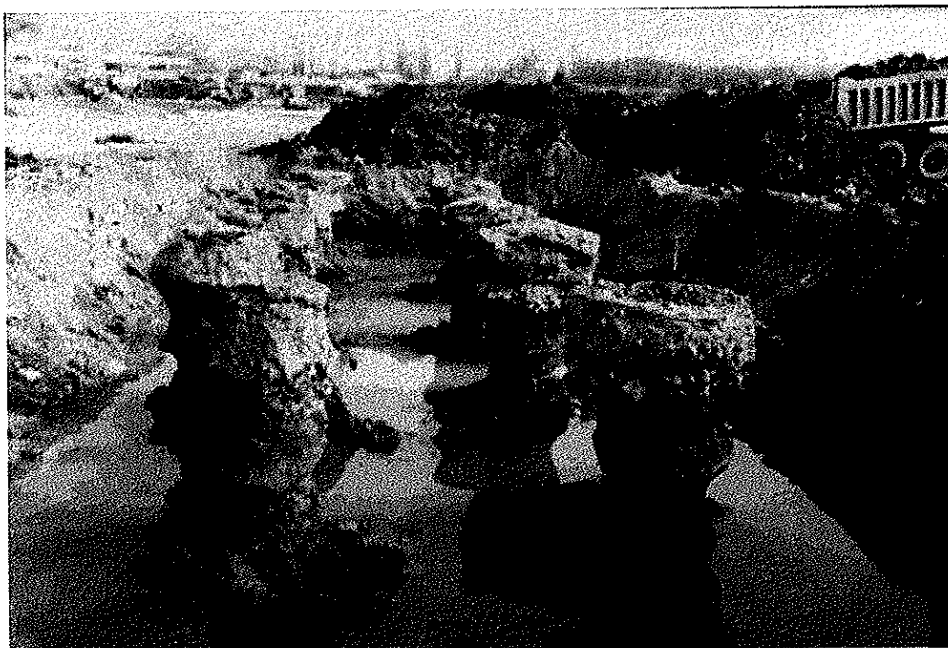
Within the first days of the application, some test columns were formed and a trial excavation was made in order to trace the following concepts (Figure 1):

- to inspect the jet grout columns visually,
- to perform resulting diameter control,
- to control the column verticality,
- to assess the column configuration at the site (control of the distance between the columns).

Figure 1. Trial excavation of jet grout columns (Eker. 1999)

Under such difficult conditions, the results of the trial excavation were successful. The constructed test bodies showed that the combination of the predetermined operational parameters resulted in obtaining the required project diameter (80-cm) in the subject cohesive soils. Also, in randomly excavated areas of the site, the required diameter of the columns was maintained.

In addition, the column verticality was observed as satisfactory. It was assessed that the project configuration was successfully applied and distance between the columns was appropriate.

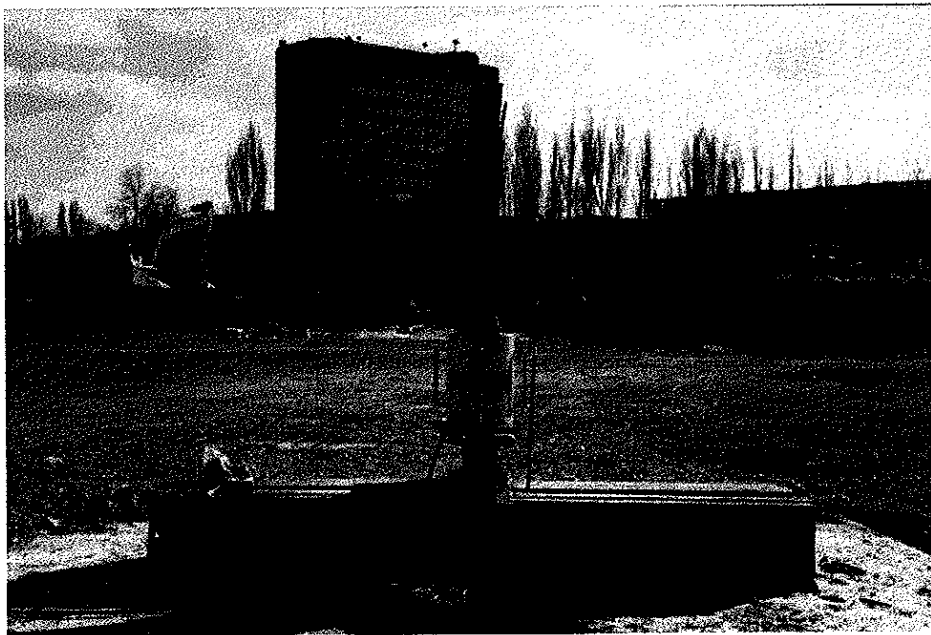
According to the project requirements, nine pull-out tests were employed in order to determine the load capacity of the columns. Before the test, a reinforced concrete foundation was constructed for each test column and at least 30-cm distance was provided between the test column and this foundation. An anchorage tendon formed of 10 steel rods of 0.6-inch diameter was placed inside the test columns. In addition, reaction beams for the axial loads, hydraulic jack, hydraulic pump, manometer, and other measurement tools were placed conveniently in the test area (Figure 2).

Figure 2. Pull-out test configuration (Eker, 1999)

In the test, by the hydraulic pump, the static tension load was transferred to the hydraulic jack that was placed over the column head and the reaction beams under certain pressure levels. Because of the rigid system, the column moved vertically under loading. These displacements in the column were measured independently from the column and other pressure components.

The column loading was performed in two cycles. The test load was determined to be 100 tons. In the first cycle, it was reached to 50 tons by 25 per cent load increments with 60-minute periods and then the load was discharged with 15-minute intervals. In the second cycle, it was tensioned up to 50 tons by 25 per cent load increments again and then it was tensioned up to 100 tons with 60-minute intervals with the same increments. The load was again discharged with 15-minute periods (ZETAŞ, 1999).

In order to inspect the column behavior more effectively and observe the permanent displacements, loading was tensioned up to 175 tons in six columns, 165 tons in one column and 162.5 tons in two columns. Consequently, it was tried to determine the column behavior under a load of nearly 70 per cent higher than the test load.

According to the test loads, the maximum permanent displacement was recorded as 4-mm. This displacement value was obtained under 162.5 tons that was 62.5 per cent higher than the test load so the column was determined to be safe under 100 tons that was the project load. It was also observed 0.5-mm and lower displacement values in six columns (Eker, 1999).
