FOUNDATION PROBLEMS OF KONYA ALAEDDİN MOSQUE AND IMPLICATION OF REMEDIAL MEASURES

H.T. Durgunođlu(1), T. Karadayılar(2), C. G. Olgun(1)

ABSTRACT

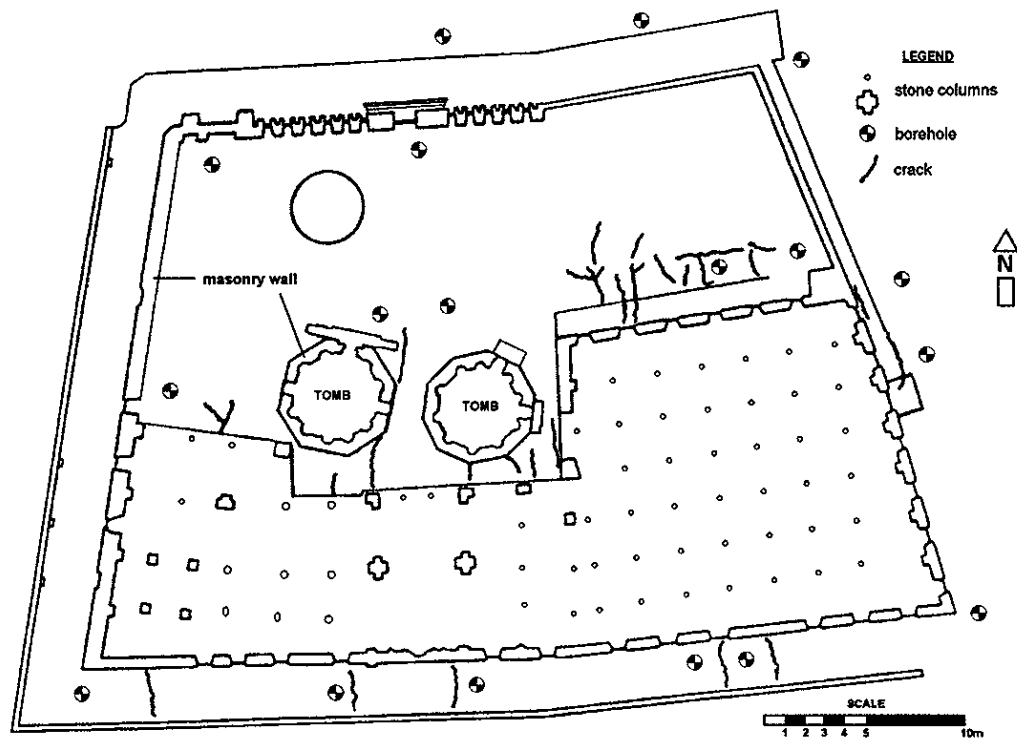
Figure 1. Konya Alaeddin Mosque, location of structural elements

Konya Alaeddin Mosque was built in the twelfth century by the Seljuks, on Alaeddin Hill known to be a man-made artificial fill. The monument, has taken its final form in time with various revisions and extensions along the eastern and western sides. It is observed that remnant pieces have been used in construction and the structural system is formed of masonry arched resting on stone columns. A plan of the mosque showing the locations of the masonry walls and the stone columns is given in Figure 1.
