High-Modulus Columns for Liquefaction Mitigation

James R. Martin II, A.M.ASCE¹; C. Guney Olgun, S.M.ASCE²; James K. Mitchell, Hon.M.ASCE³; and H. Turan Durgunoglu, M.ASCE⁴

Abstract: This paper presents the performance of a shopping complex in Turkey where the soils were improved with jet-grout columns and preload fills and subjected to the 1999 Kocaeli Earthquake ($M=7.4$). Under construction at the time of the earthquake, the Carrefour Shopping Center covers an area of 55,000 m² and is founded on shallow footings, mats, and slabs-on-grade that rest on soft, saturated alluvial sediments consisting of clays, silts, and sands. High-modulus columns constructed by jet grouting were installed at close-to-moderate spacings to reduce anticipated static settlements in the clays and mitigate liquefaction in the sands. The site was subjected to a peak acceleration of approximately 0.2g during the earthquake. Grouting had been completed for about two-thirds of the site when the earthquake struck. Following the event, a field reconnaissance found stark contrast between the performance of the improved and unimproved sections. The jet-grout-treated areas suffered no apparent damage, whereas th

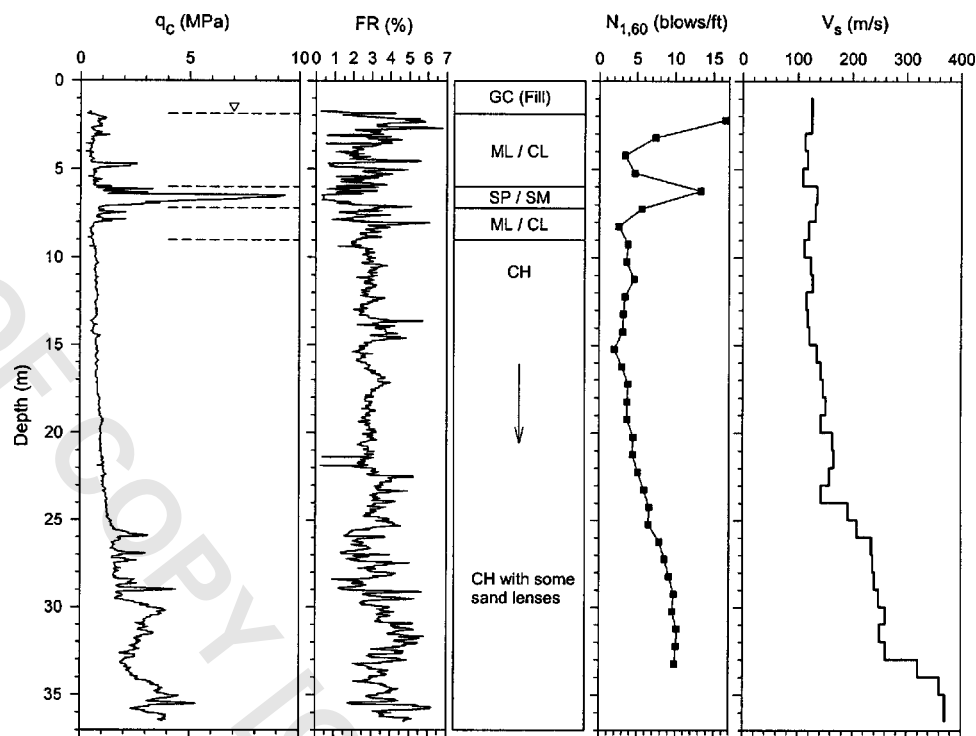
The extensive array of CPT and SPT data indicated that the stratigraphy is highly variable with depth, but conditions are fairly uniform in lateral extent across the site. A typical profile and penetration test data from the site (for untreated conditions) are presented in Fig. 3. It can be seen that the CPT tip values are low, and with the exception of a 1-m-thick zone at a depth of 6 m, the values average about 1 MPa throughout the upper 20–25 m of the soil profile. SPT $N_{1,60}$ blowcounts are less than 10 blows/ft in most strata above 25 m. Shear wave velocities were measured by means of four post-earthquake seismic CPTs and indicated 110–140 m/sec for the top 10 m. A composite soil profile for the site was established from the penetration tests and is shown in Fig. 4 (see section A-A' in Fig. 2).

Fig. 3. Typical preimprovement geotechnical parameters from Carrefour site

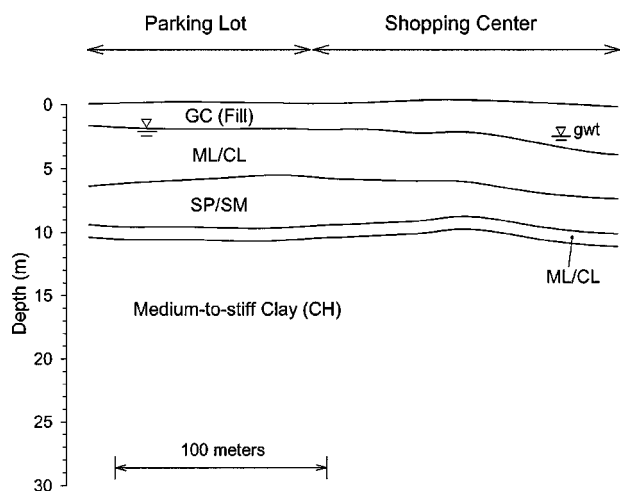
As can be seen in the figure, a medium dense clayey-gravel fill (GC) overlies the entire site, extending from the ground surface to an average depth of about 3 m. The fill was placed decades prior to construction to reclaim the site from Izmit Bay. The fill varies from 2 to 4 m in thickness across the site and is thickest beneath the shopping center. The fill is located above the water table in most areas.

Fig. 4. Generalized soil profile through Parking Lot and Shopping Center area; see A-A' in Fig. 2. (Note: horizontal scale is compressed.)

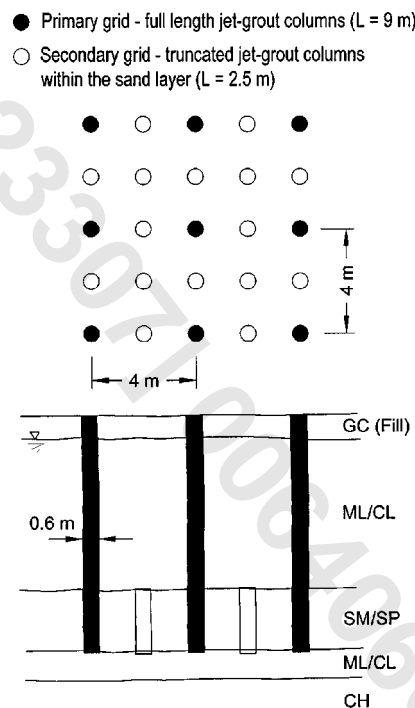
Fig. 5. Layout of jet-grout columns used for blanket treatment beneath Shopping Center building at Carrefour site. Additional columns were used at footing locations to provide additional bearing support. Average replacement ratio beneath building was about 7% in the SM layer and 2% in overlying strata.
